**ANALYSIS OF HVDC THYRISTOR
CONVERTER TRANSFORMER
PERFORMANCE**

**Joint Task Force
B4.04 /A2-1**

February 2004

CIGRÉ -- International Council on Large Electric Systems

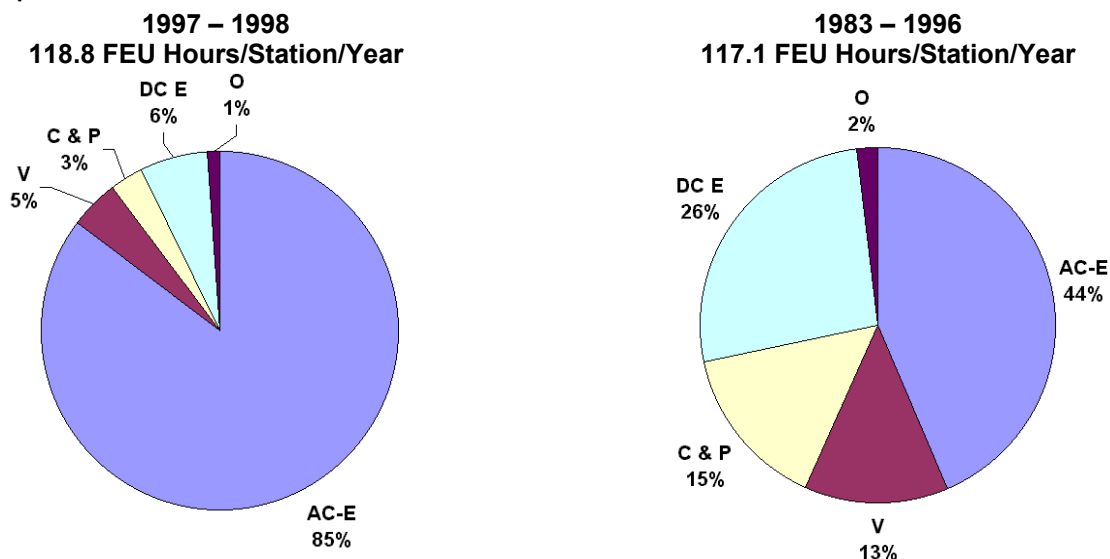
**Figure 1 - CIGRE WG B4.04 All Reporting Thyristor HVDC Systems
Breakdown of Average FEU By Electrical Category***

HVDC systems are continuing to perform satisfactorily (118.8 FEU current, versus 117.1 FEU historical) however, the AC and Auxiliary Equipment (AC-E) portion has grown substantially from a 1983 – 1996 value of 44% to the current 1997 – 1998 value of 85%. This increase with time is due to the effect of a number of converter transformer failures, however, the reason for the increase transformer outages was incomplete. One set of the CIGRE2000 SC B4 special reporters questions relative to the WG B4.04 technical paper were:

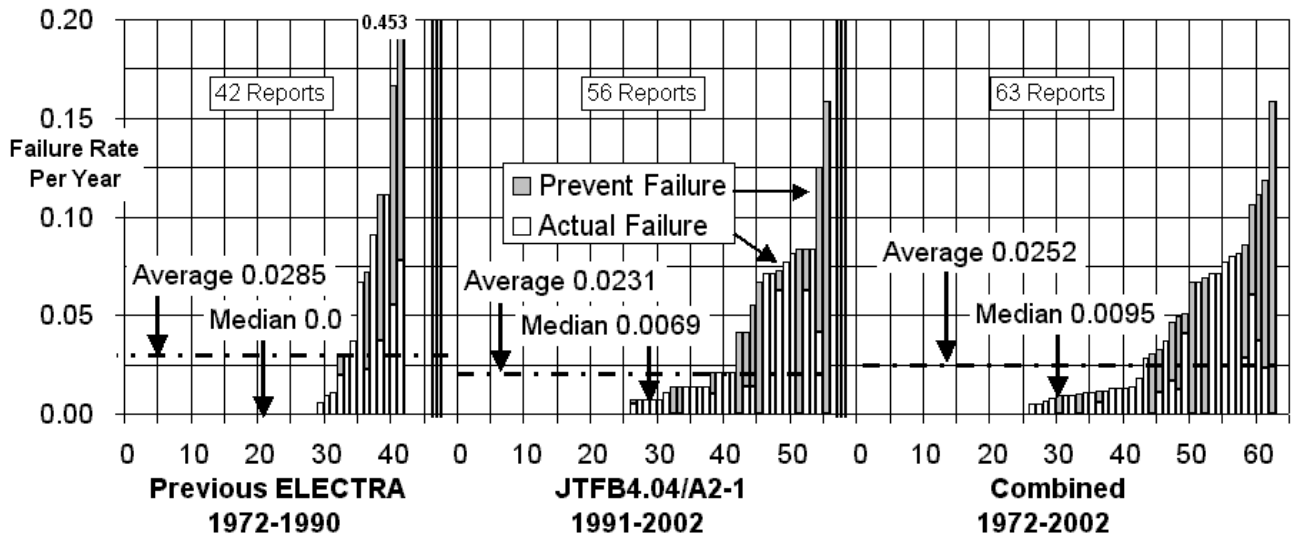
Figure 2 – Sorted Individual System/Subsystem Failure Rates*

The failure rates per year illustrated in Figure 2 indicate a relatively high and somewhat consistent average of 2.85% for 1972 – 1990, 2.31% for 1991 – 2002 and 2.52% for the combined 1972 – 2002 periods. In regard to the Special Reporter question: “Are the converter transformer problems unique to only those specific systems?” There are several systems having failure rates greater than 5% per year with seven (17% of the reports) for 1972 – 1990, 12 (21% of the reports) for 1990 – 2002 and 14 (22% of the reports) for the combined 1972 – 2002 period. Transformer forced outage time for major failures is dependent on having spare transformers, which has a direct effect on system availability. The outage time, to some degree, may be determined from the failure descriptions of each transformer within this report. The median failure rates discount the effects of the higher values and are 0 (29 reports or 69% with no failures) for 1972 – 1990, 0.69% for 1990 – 2002 and 0.95% for the combined 1972 – 2002.

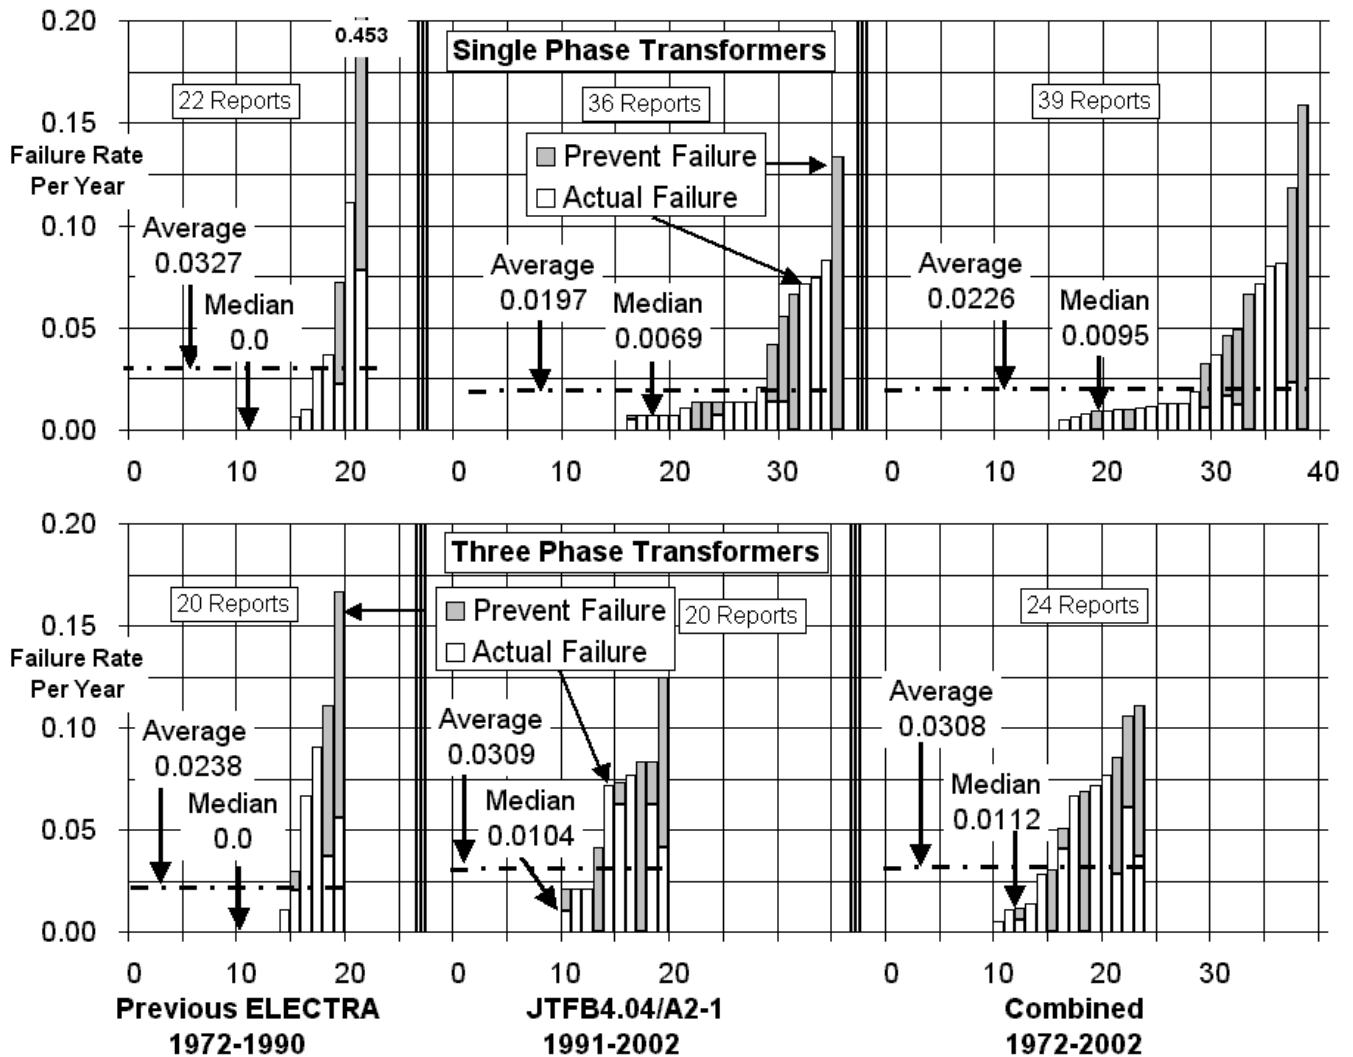
**Figure 3 – Single Phase – Three Phase
Sorted Individual System/Subsystem Failure Rates**

The Figure 3 comparisons of single-phase with three-phase transformer failure rates per year indicate single-phase transformers have a lower failure rate except for the Previous ELECTRA [1] report. This is caused by Itaipu failure rate of 0.453 based on 192 operation years with 15 actual and 72 prevent failures. If Itaipu is removed the average failure rate is reduced from 0.0327 to 0.0127. If the Itaipu 1972 – 1990 data is removed from the Combined Report the average failure rate is reduced from 0.0226 to 0.0197.

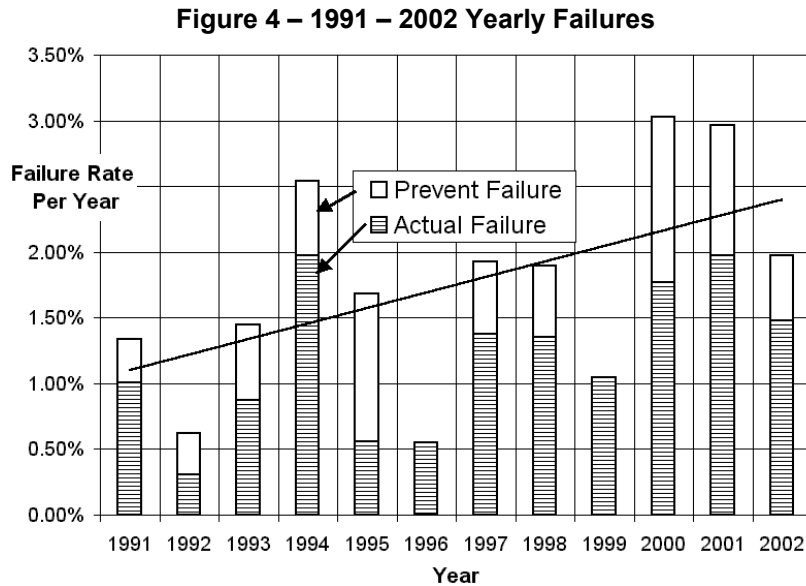
Figure 4 is a bar chart of the annual failure rate data in Table 4 obtained from the JTF 1991 -- 2002 survey. Although the previous report when compared with the JTF survey data indicates average failure rates are high and have decreased slightly, the trend line of Figure 4 illustrates an increasing failure rate from 1991 through 2002.
