**INVESTIGATION ON THE STRUCTURAL INTERACTION  
BETWEEN  
TRANSMISSION LINE TOWERS AND FOUNDATIONS**

**Working Group  
B2.08**

**October 2009**

## Investigation on the structural interaction between Transmission line towers and foundations

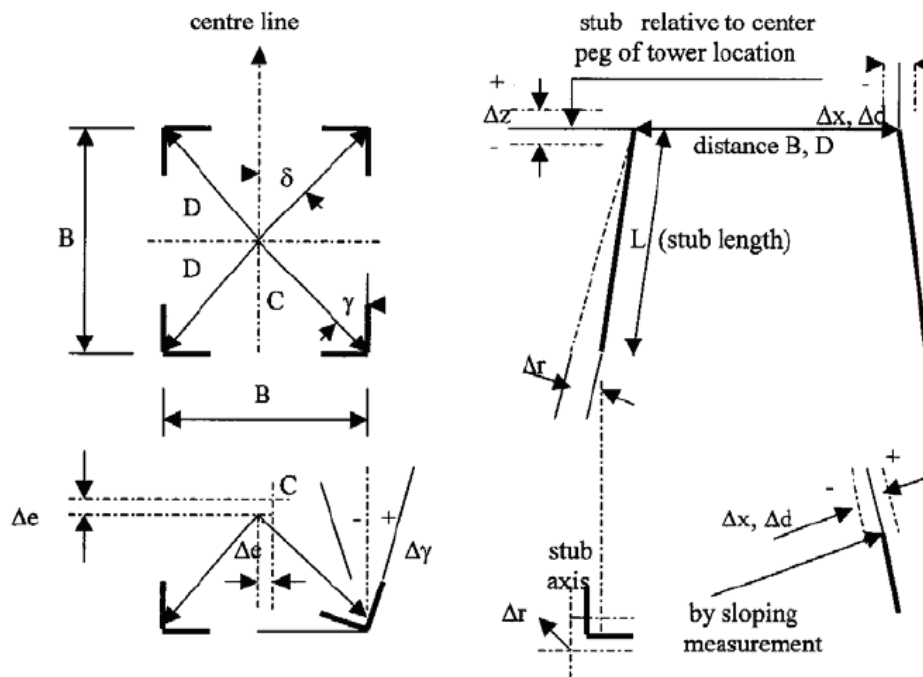
**Figure 1: Tolerances for tower erection**

Regarding erection, the foundations are allowed some tolerances, such as those suggested, for example, by F. Villa [2], (Table 1 and Figure 1):

Tolerance	Allowed values
Base width	$\Delta x \leq \pm 0,1 \%$ length of width length B
Diagonal distance	$\Delta d \leq \pm 0,1 \%$ length of diagonal length D
Stub level	$\Delta z \leq \pm 0,1 \%$ length of width/2 (B/2)
Batter axis	$\Delta r \leq 0,5 \%$ length of stub above the concrete top length L
Angular distortion	$\Delta \gamma \leq \pm 0,5^0$ (degree) on stub angle twist angle $\gamma$
Tower distortion	$\Delta \delta \leq \pm 3^0$ (degree) on centre line
Tower eccentricity	$\Delta e \leq \pm 0.5\%$ length of diagonal length D

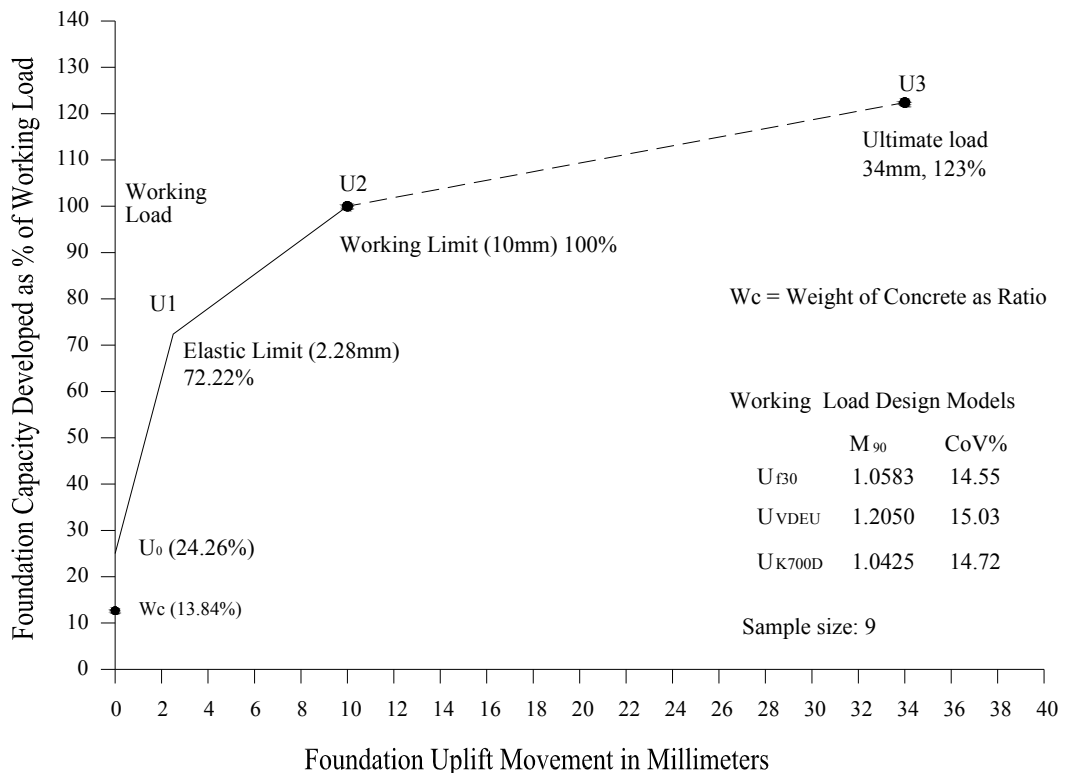
**Figure 2: Foundation movement versus Foundation Capacity**

Regarding the application of the IEC 60826 methodology, capacity estimation models have been calibrated through the comparison with test results. Examples of these efforts are those carried out by WG B2.07[3], reported for a shallow foundation submitted to uplift, which may be exemplified by figure 2.

From these studies, expressions similar to those shown below can be established. For example, supposing that the limit displacement for the service condition is about 10mm, the design equation for the foundation “serviceability limit state” would be:

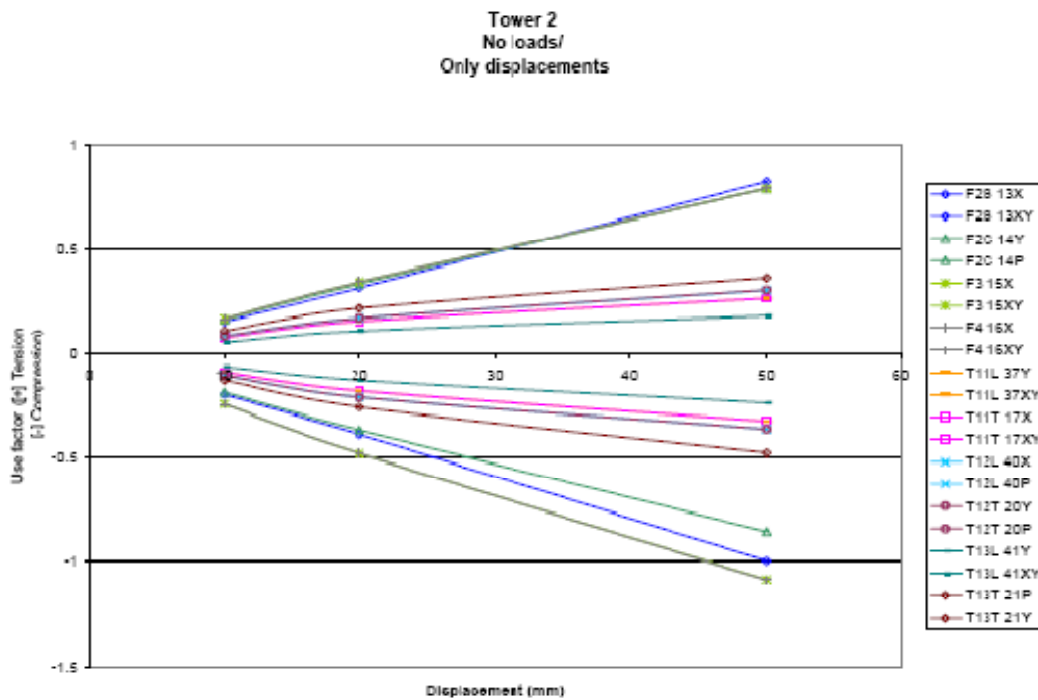
Figure 5: Study to determine test displacements

The structural response was analyzed in order to establish a member force value to be imposed on the structure leg. The purpose of these calculations was to determine displacements that would allow a safety margin during the tests, considering the presence of workers operating devices during the application of the displacements. The results of these calculations can be summarized in figure 5 below. This figure shows that bar F4 (main member) achieves its ultimate capacity (that is, use factor equal to -1, in compression) close to 46mm of foot displacement. Considering this result, the limit of 25mm was established during the tests, as this value is adopted in many countries around the world as the maximum acceptable limit by industry practices.

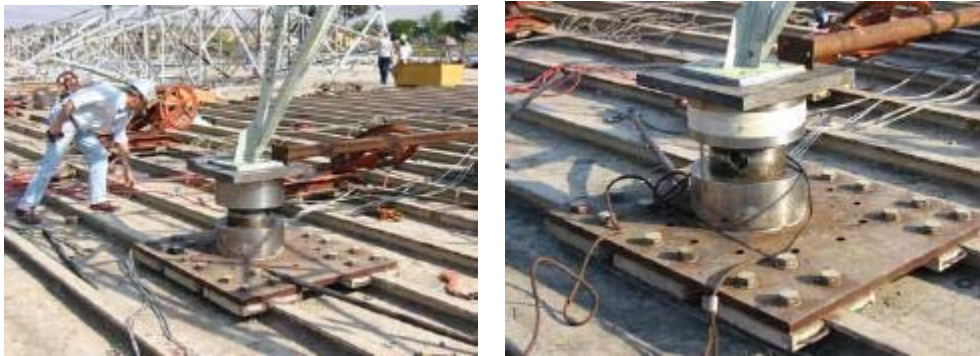
**Figure 7: Device designed for application of displacements on tower**

A special device was designed for the application of the displacement at the tower foot, as shown in figure 7.

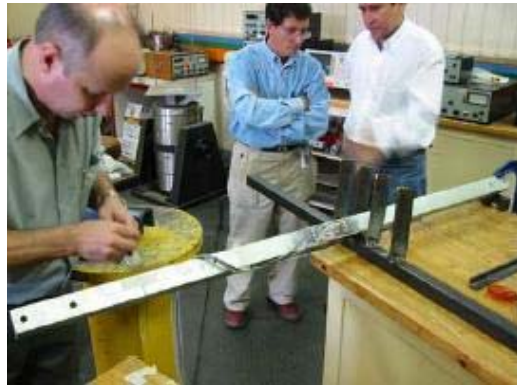
Figure 8: Calibration of a strain gaged member

The complete strain gaged member was calibrated under the unloaded bar condition (figure 8), establishing the proportionality constants for determining member strain (load) and then, after the erection of the tower, “zeroing” the values when the external loads were not acting. Annex A contains the complete test results.

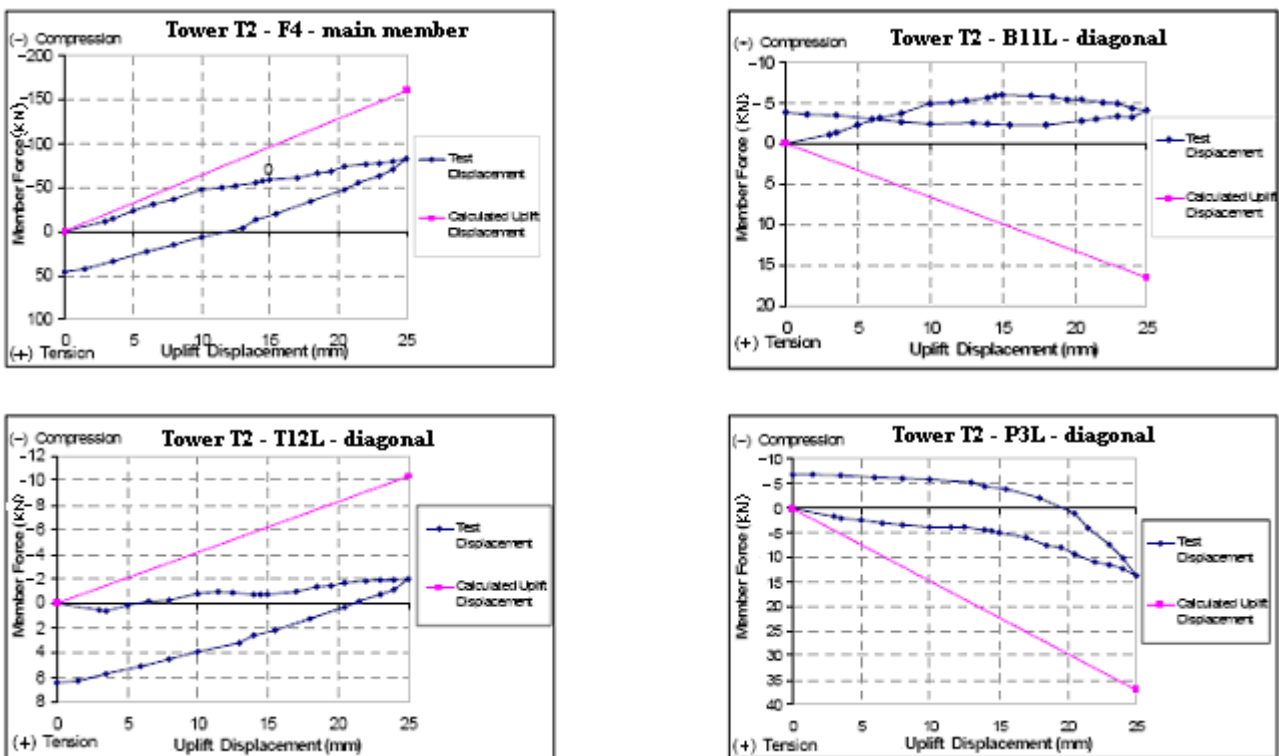
Figure 9: Test results *versus* estimate

Some of the test results, as compared with the corresponding predictions, can be seen in the following figures (figure 9). In these figures, bars F4 is a main member, bar B11L and T12L are longitudinal diagonals, and bar P3L is a tower leg diagonal. In Annex B are shown the “estimated *versus* measured” loads on all monitored bars for the uplift test.

The test results show a general trend that the measured values are reasonably lower than those calculated using linear models, that are currently used in design practice.

- Looking at the graphs of the Figure 9, it can be seen that all the initially estimated values for bar loads were larger than those measured. The current industry calculation practices are, generally, on the conservative side. The real tower behavior and accommodation movements could be seen during the tests, and assessed by post-tests calculations using refined analysis models. The non-linear analysis that take into account bolts slippage on joints simulate well what happens when the structure experiences small foundations displacements. Those calculations can be seen on graphs of Figure 10. The bolts slippage acts as “relievers” on the main members loads and, so, the graphs show better calibrated values.

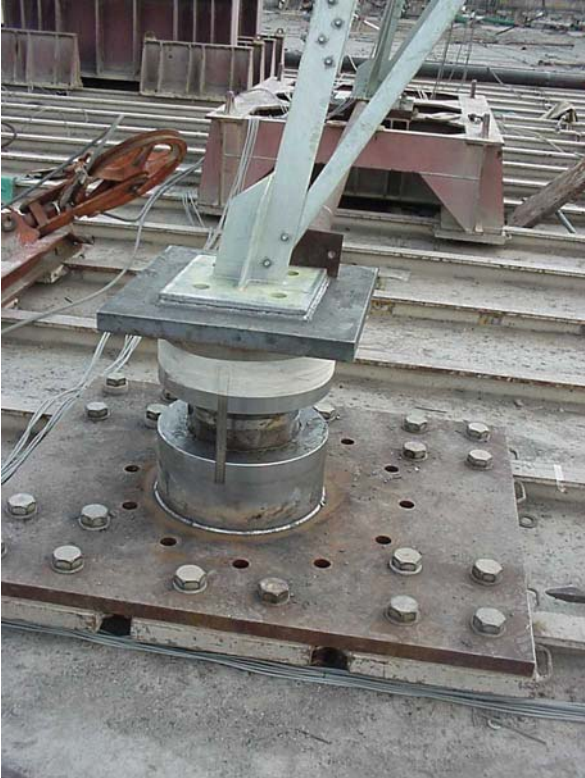
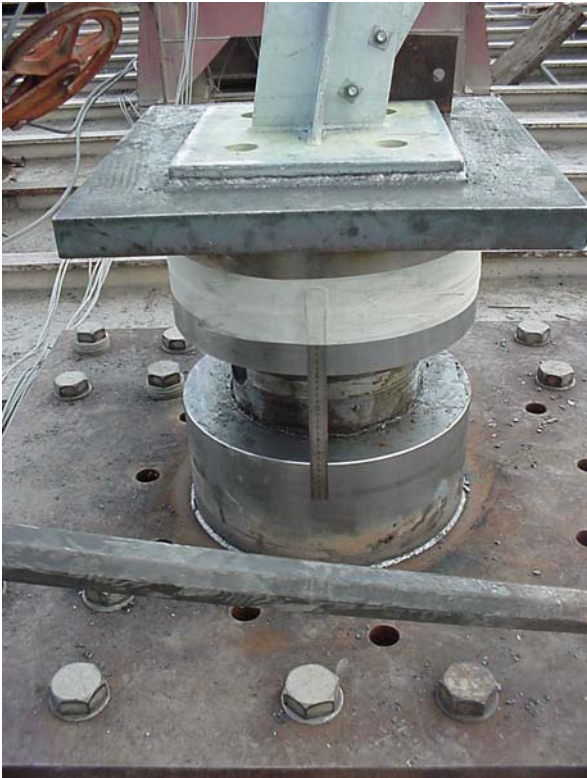
**A.2 – FOUNDATION MOVEMENT AJUSTABLE DEVICE**

**ADJUSTABLE FOOT USED DURING THE FOUNDATION DISPLACEMENT TEST**

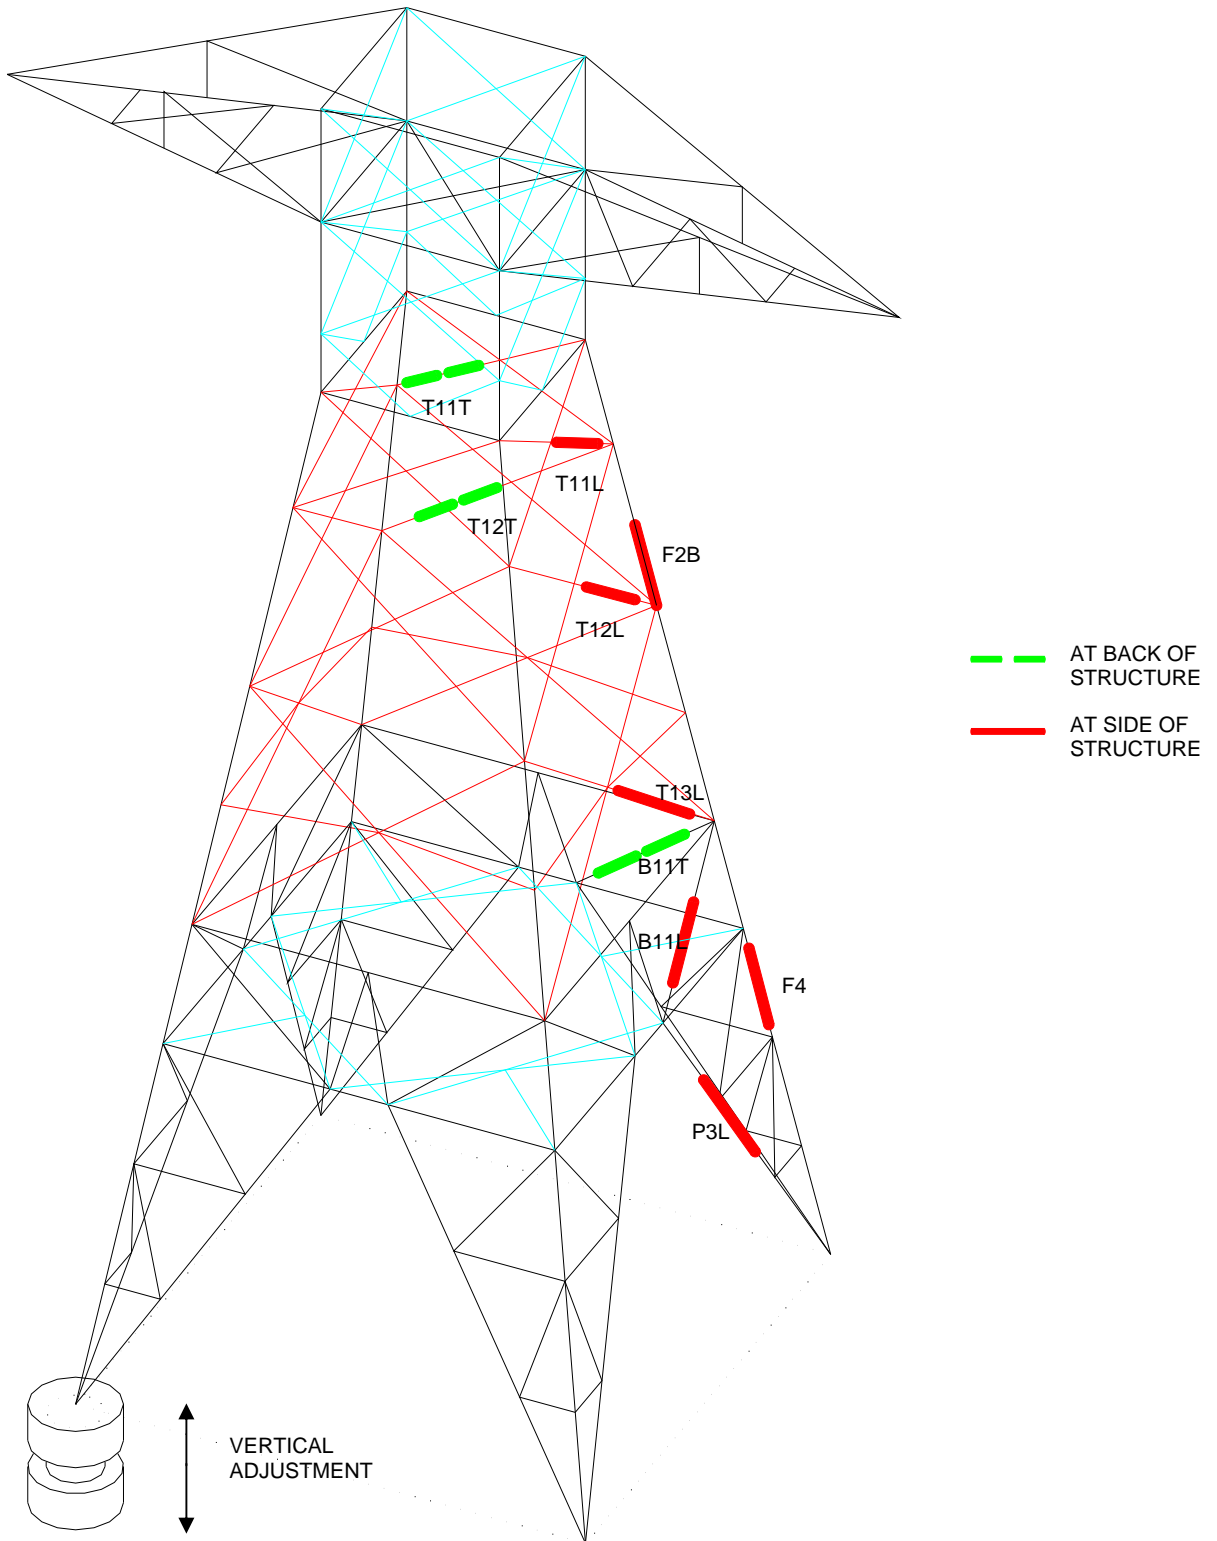
The bars that were strain gaged monitored during the foundation displacement tests can be seen in the following drawing:

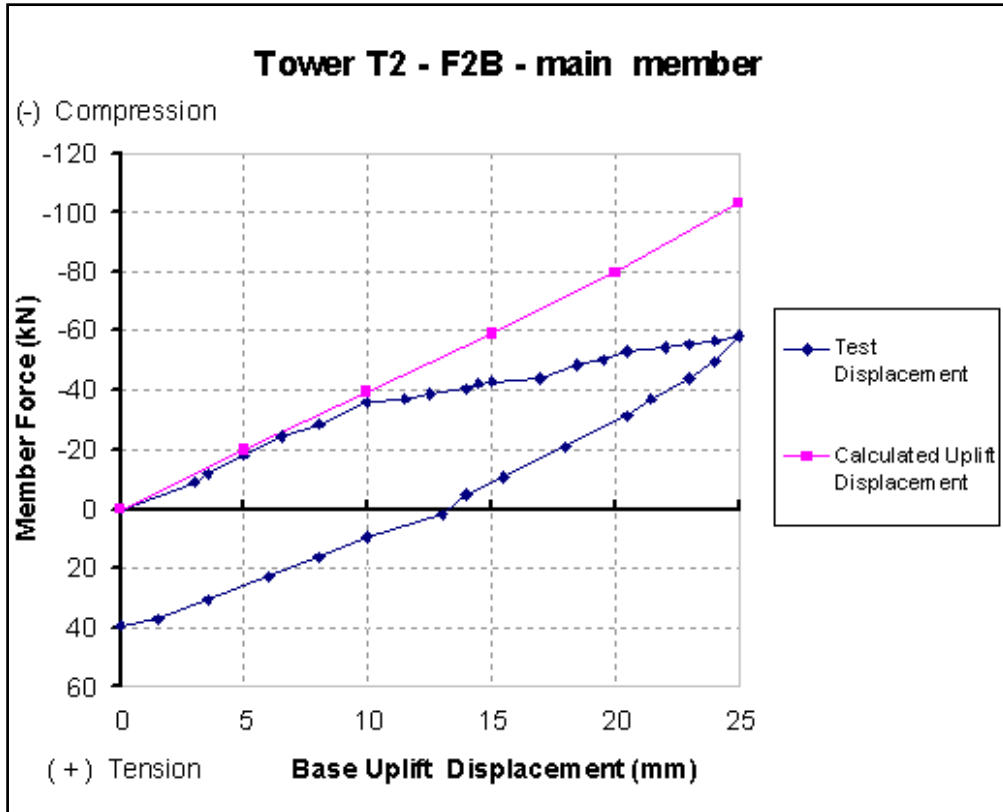
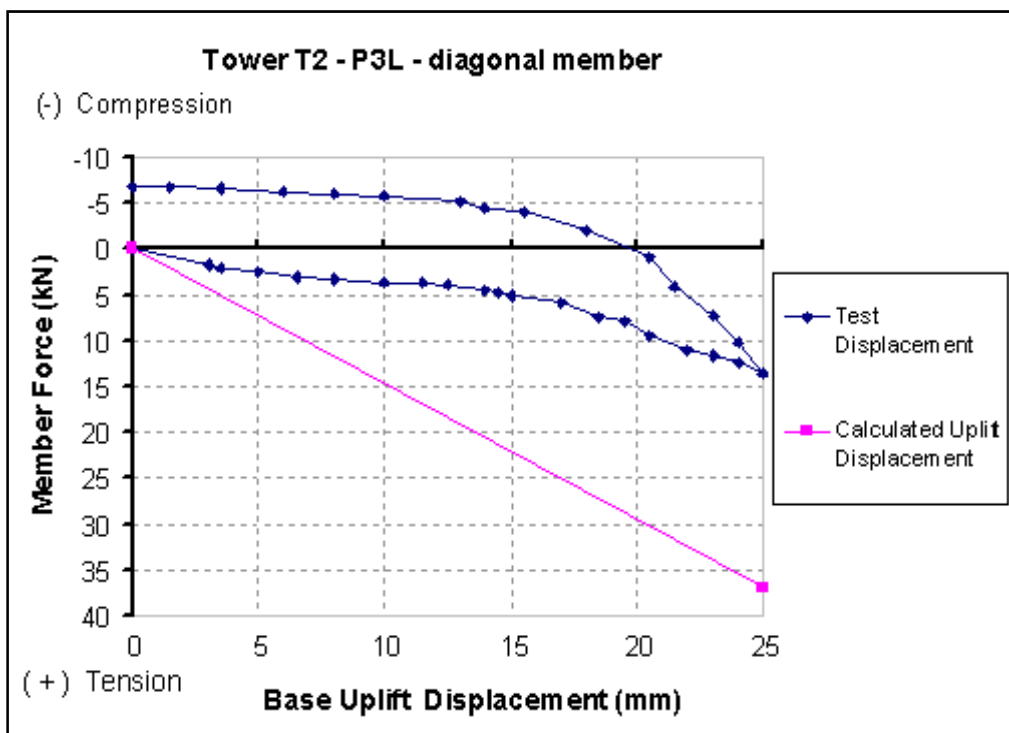
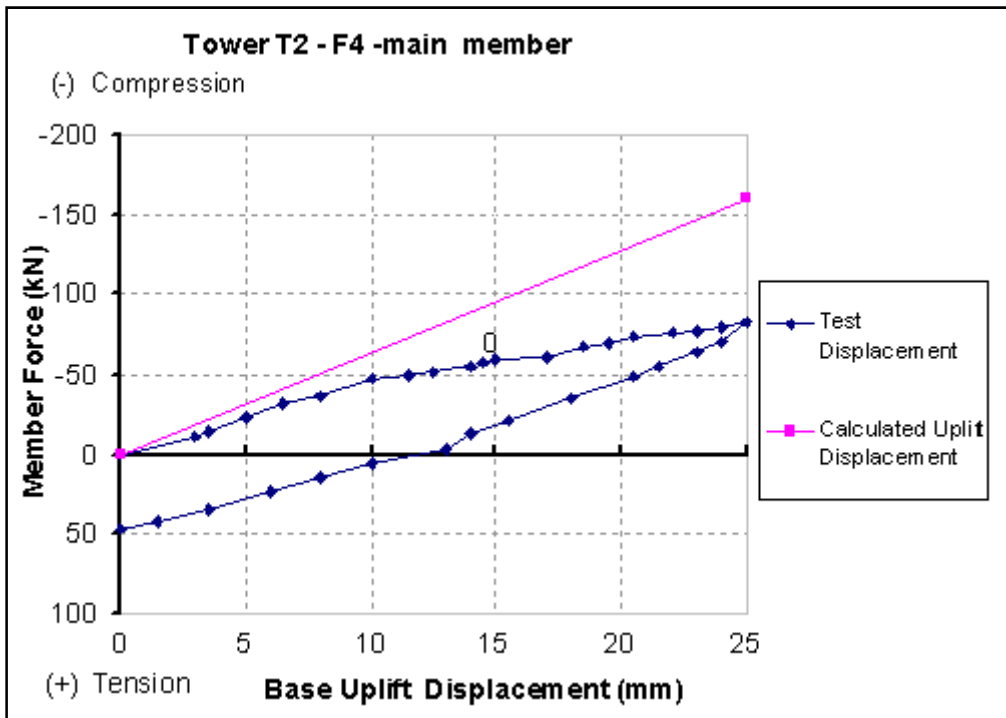
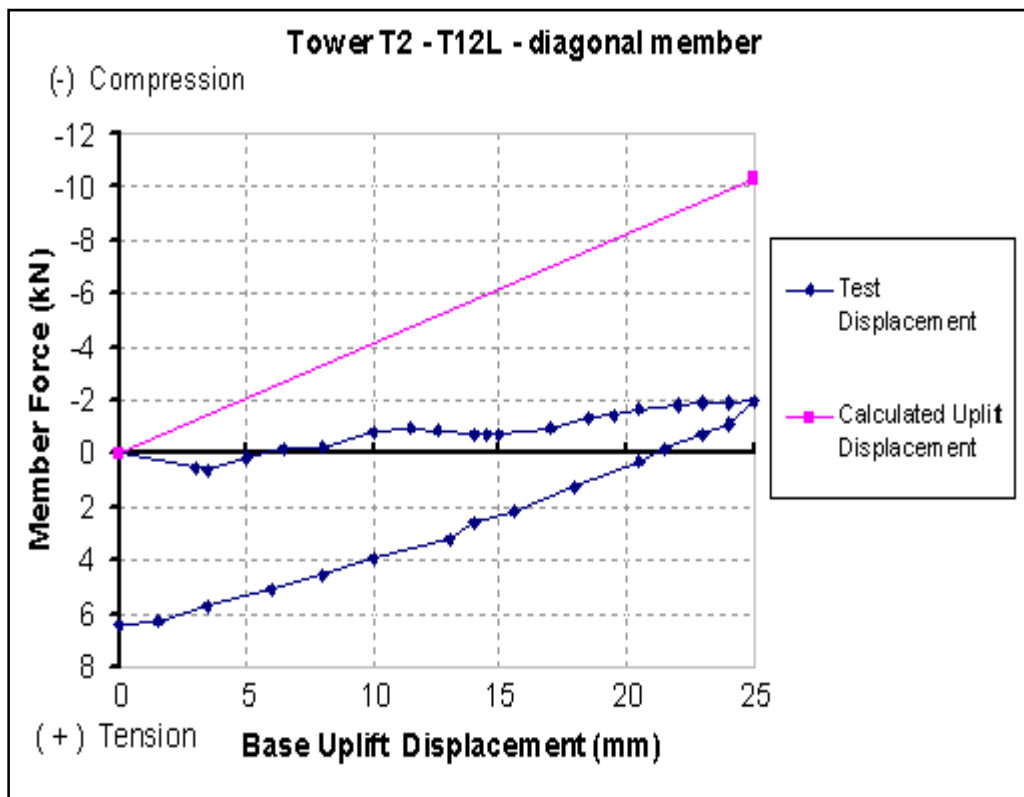
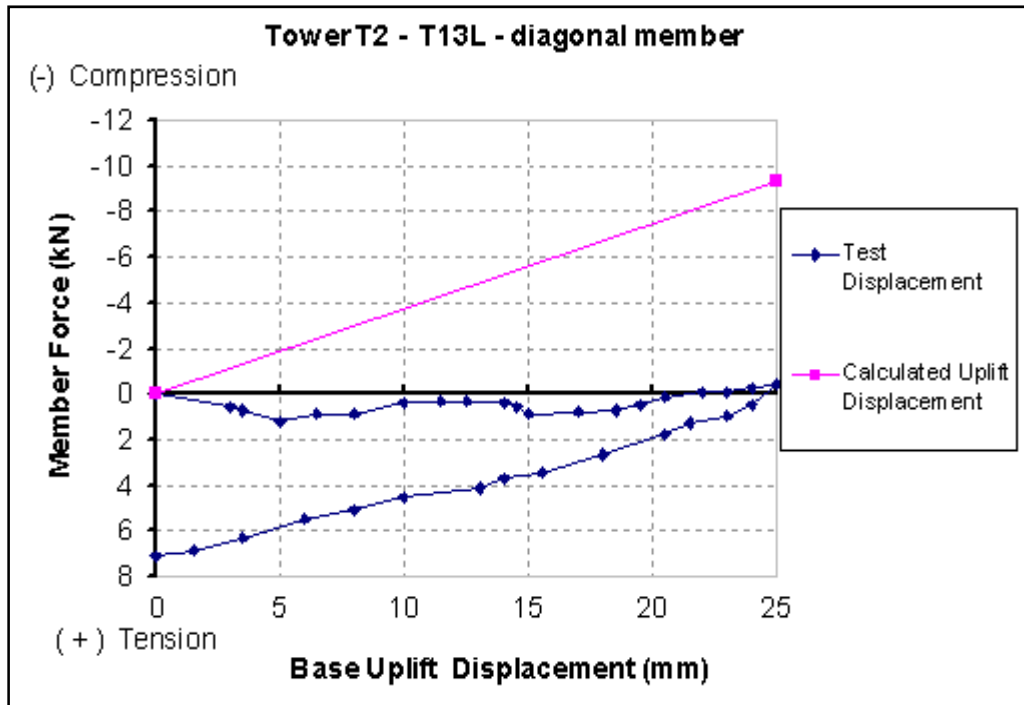
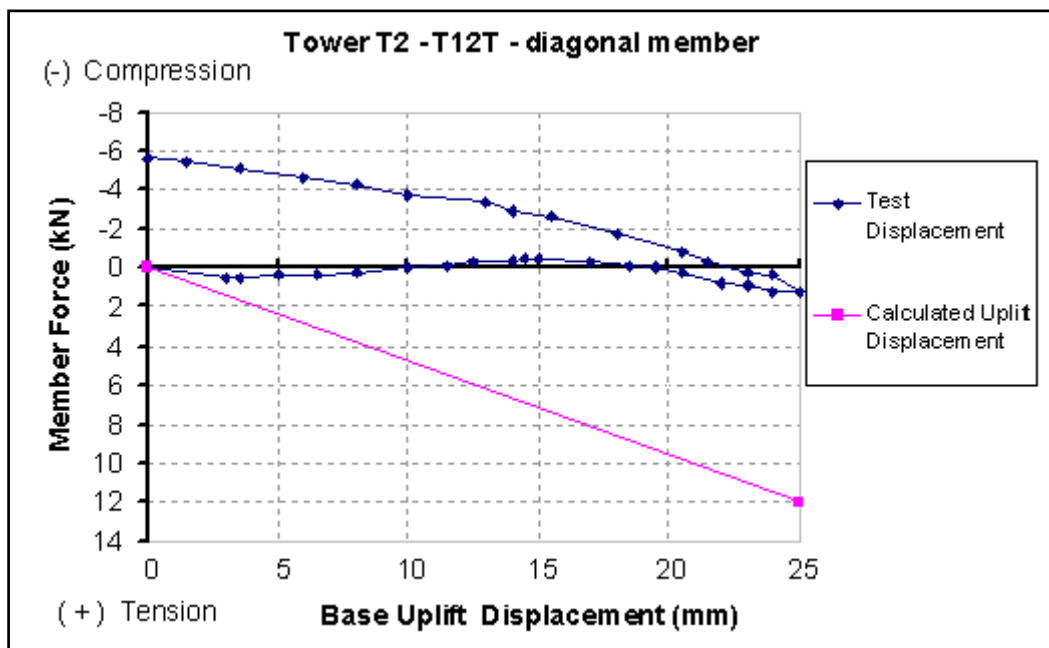
## B.2 – ESTIMATED *versus* MEASURED LOADS

### UPLIFT DISPLACEMENT TEST
