**GUIDELINES FOR INCREASED UTILIZATION
OF
EXISTING OVERHEAD TRANSMISSION LINES**

**Working Group
B2.13**

August 2008

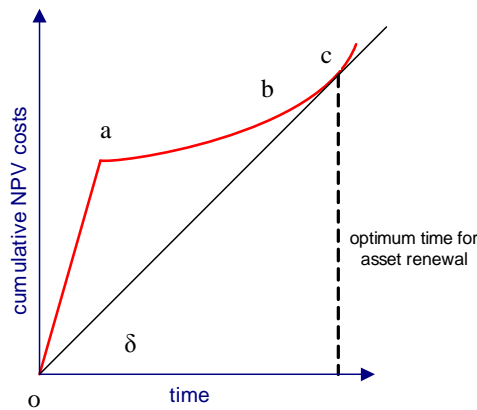
Figure 2: Economic Model of a Transmission line

One should however also consider the *economic end of life*. Let us then consider the cumulative net present value (NPV) of the cost of the transmission line asset including depreciation, maintenance, losses and risk costs per years of service as illustrated in Figure 2. The cumulative NPV of costs are the initial capital expenditure (o to a) followed by the NPV of recurrent costs (a to b), followed by a period of increased recurrent cost as a result of the early stages of asset deterioration and increased maintenance activities (b to c) and then followed by an accelerated and an increasing recurrent maintenance costs (after c).

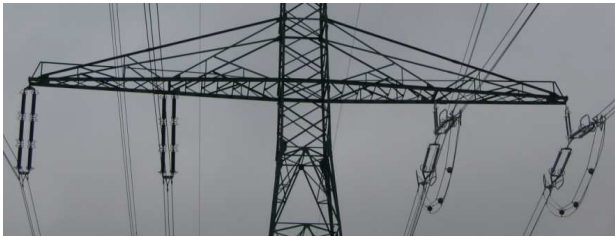
<p>Line Thermal Uprating (Czech Republic) bundle conductors are attached at a higher level thanks to a T insulator string arrangement. On the left: previous situation and on the right: new arrangement.</p>

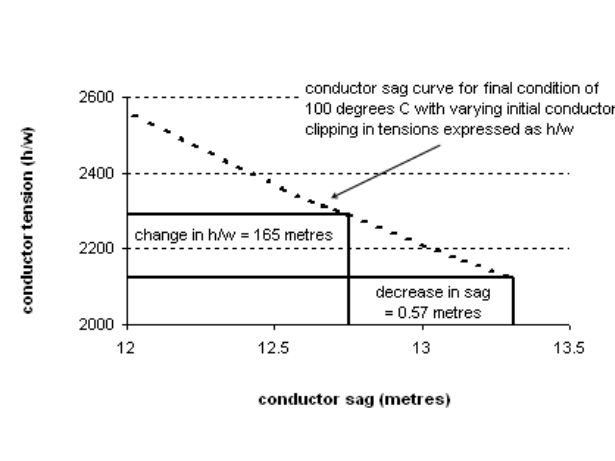
<p>conductor sag curve for final condition of 100 degrees C with varying initial conductor clipping in tensions expressed as h/w</p> <p>change in h/w = 165 metres</p> <p>decrease in sag = 0.57 metres</p> <p>conductor tension (h/w)</p> <p>conductor sag (metres)</p>	<p>Line Thermal Rating (Australia) increasing the 207 mm² ACSR conductor thermal capacity by 15% by increasing the operating temperature from 85 °C to 100 °C permitted an increase in the current carrying capacity from 565 to 655 A (15%). The conductor tension parameter was required to increase from 2124 meters to 2289 meters or an increase of about 8% to compensate for the increased conductor sag of about 0.57 meters in a 400 meter span. The increase in conductor tension and decrease in conductor sag is illustrated.</p>

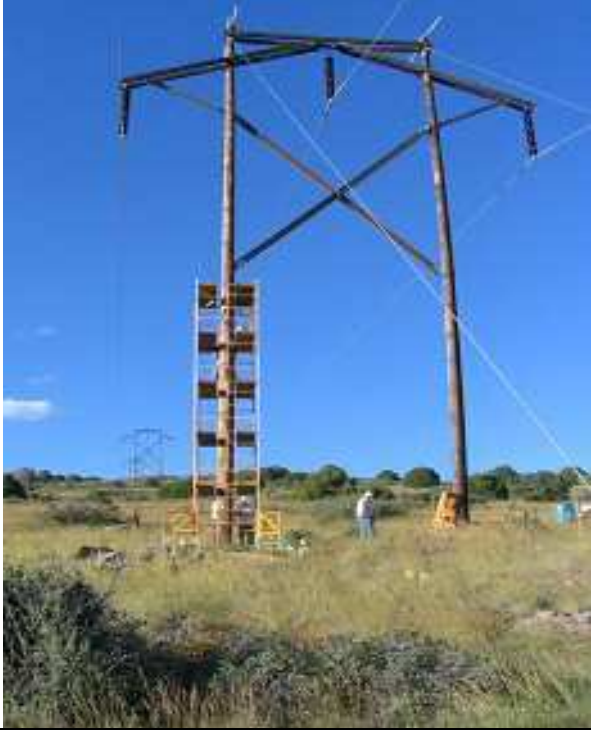
<p>Case Study 6-4 (USA) – Reinforcement of 230 kV Wood Pole K-Frame</p> <p>Case of poles severely damaged by woodpeckers and decay, in danger of failing. The line is critical to system reliability. It is not practical to schedule an extended outage in the near future to enable the necessary repairs to be performed using de-energized work practices. Access to the damaged structures is not easy. Pole replacement was deemed to be cost prohibitive. Restoring strength to the damaged pole was carried out by using composite reinforcement technology: a patented composite repair consisting of a fiberglass wrap coupled with a phenolic resin system installed over a four day period with the line energized at a substantial cost savings relative to pole replacement.</p>

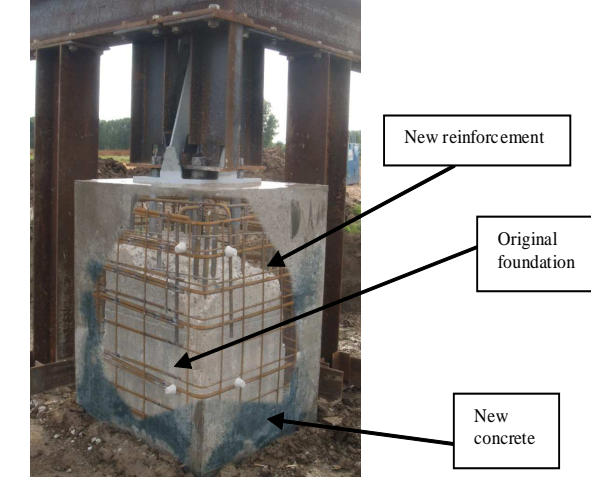
<p>Refurbishment of Concrete Foundations (ASR) of 150 kV Overhead Line (The Netherlands)</p> <p>In the overhead line there were many foundations with deformation. In 1995 the foundation of one tower had already been refurbished.</p> <p>After a new line inspection in 2005 the conclusion was that further investigation was necessary. It was found that in the concrete there were traces of alkali-silica reactivity (ASR).</p> <p>Because of the limited outage time it was decided to re-use a special temporary constructions to take over the foundation loads during refurbishment.</p>

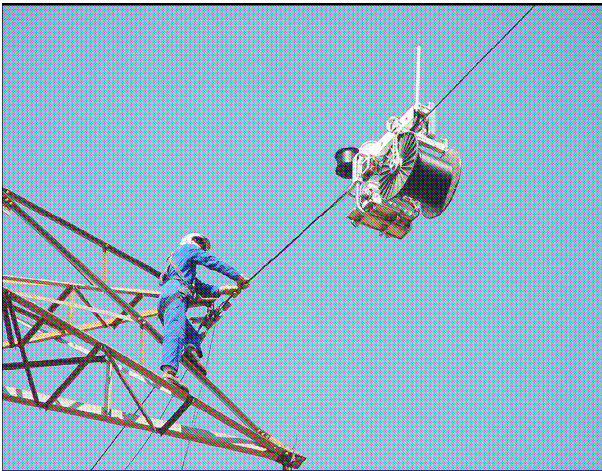
<p>installation of ADL in South Africa: 10,000 kilometers of optic fibre telecommunication network were installed on existing power lines over 14 months. Three basic technologies were employed: OPGW (Optic Fibre Ground Wire), ADL (All Dielectric Lashed cable) and ADSS (All Dielectric Self-Supporting cable). Both hand and motor lash techniques for ADL were used on 275 and 400 kV transmission lines. Due to clearance requirements between the earthwire and phase conductor the work could be done live with motor lash technique on 400 kV lines and with hand lash technique on 275 kV lines.</p>
--	---

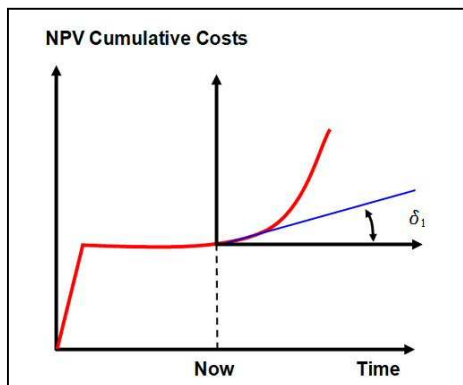
Figure 3-3

Unfortunately, a transmission line asset can not be replaced as easily as an automobile, and the economic model does not totally apply to current concerns of transmission line asset owners. The most important exception to this model is that historical initial and maintenance costs are of little concern to the asset owner. A more important concern is future maintenance and risk costs from the current point in time (i.e. “now” in Figure 3-3).

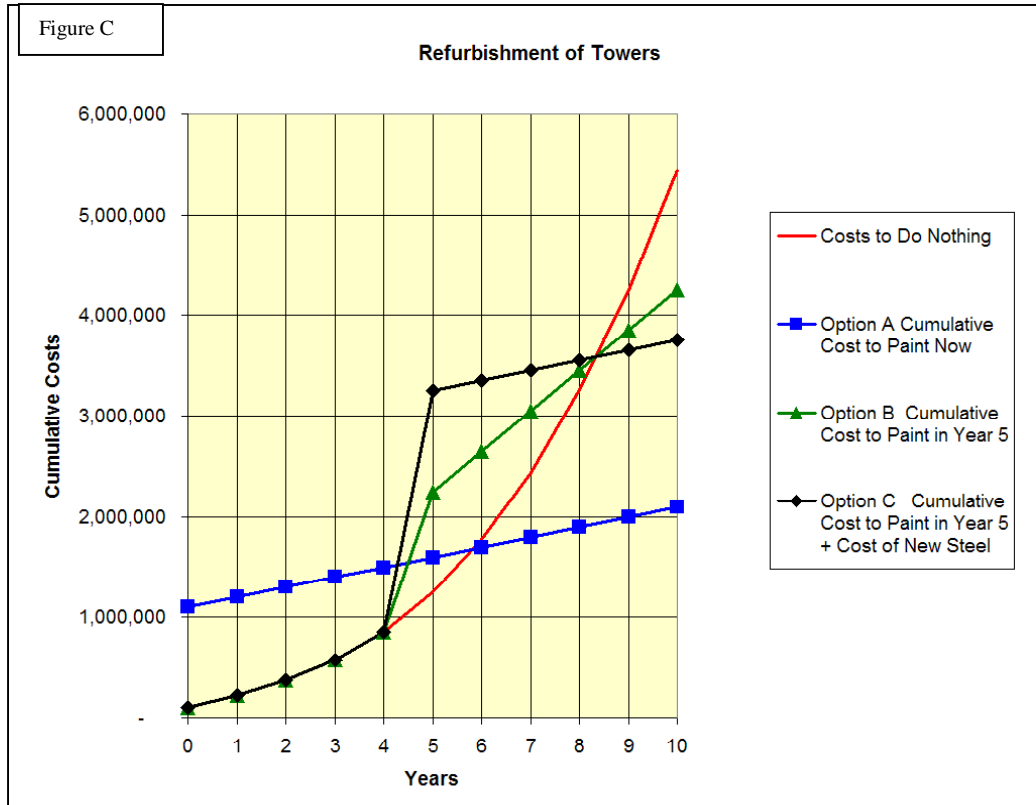
Figure C shows the comparison of these various options.

From the data presented in Figure C, the risk and cost of various decisions can be clearly seen. The breakeven for option A is approximately 6 years. Options B and C delays the expenditure for 5 years and has a faster breakeven due to the higher probability of failure. Option B continues to have a 4% probability of failure while option C restores the towers to their original strength (i.e. a 1% probability of failure).

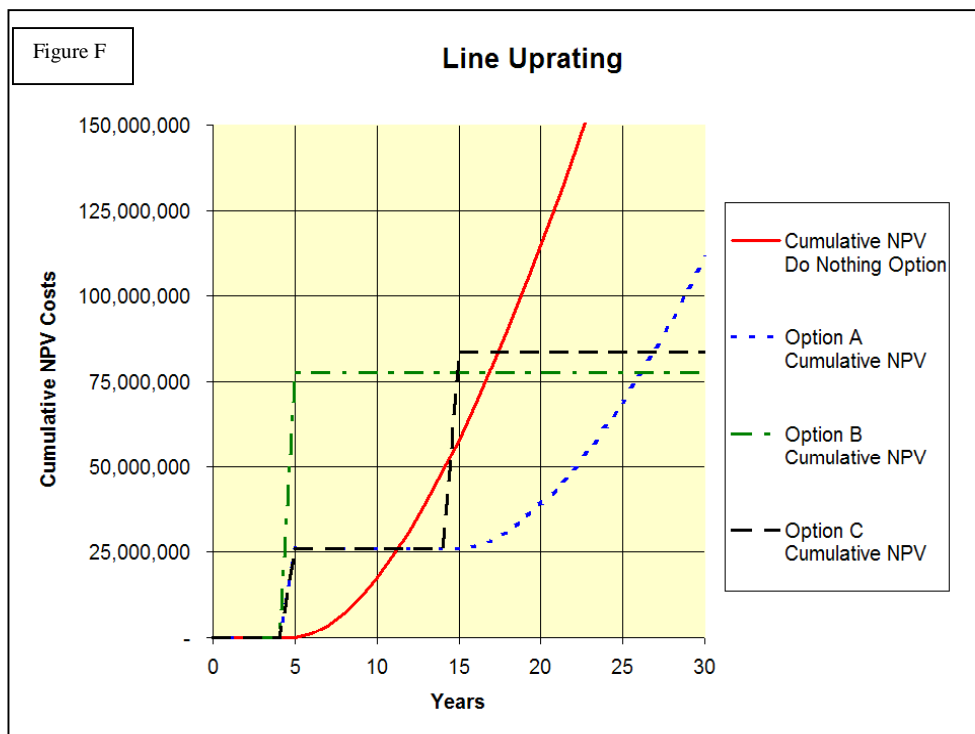
The comparison of the three options along with the “Do nothing” option are shown in Figure F.

Option A has a payback by year 11 while Option B has a payback in Year 17. However, due to the effect of the cost of capital over time, Option C may be the most attractive.

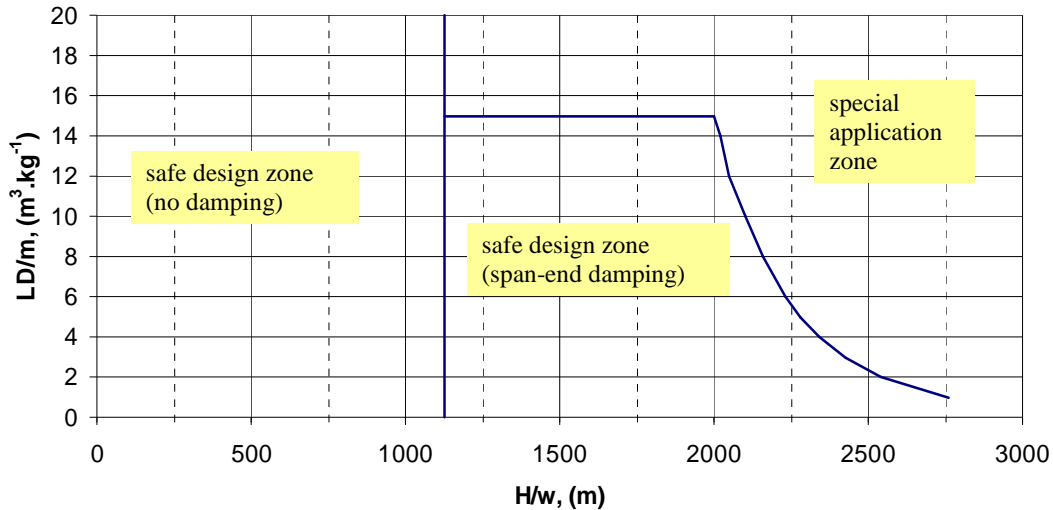
Figure 4-2: CIGRE SCB2.11.04 Conductor Safe Design Tensions Recommendation

Where: L = actual span length, D = conductor diameter, m = mass of the conductor per unit length H = horizontal tension in the conductor and w = weight of the conductor per unit length

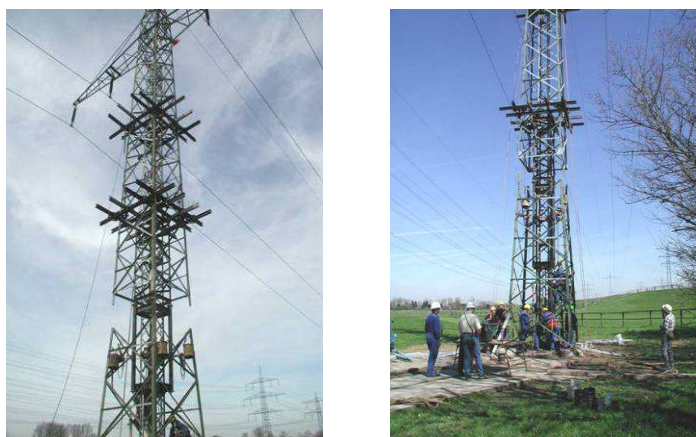
Figure 4-4: Increasing Tower Height

Increments in the tower height have generally been achieved by inserting a new steel panel into the lower portion of the tower (Figure 4-4). Usually a 2-3 meter new extension is enough to achieve the new desired clearance.

The new panel is designed in such a way (the same connection type) that it can be perfectly connected in the upper and lower parts of the structure.

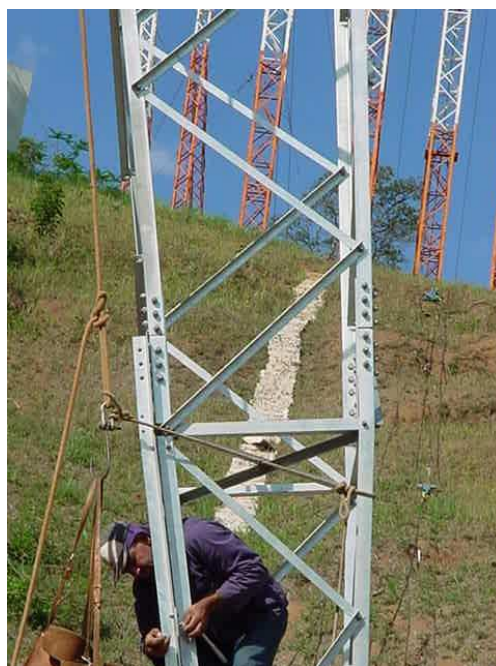
Figure 4-5: Duplication of Leg Members

The reinforcements on the existing lower body can consist basically of duplication of the main members (Figure 4-5) or complete substitution for bigger ones. Replacement of cross bracing members may also be required.

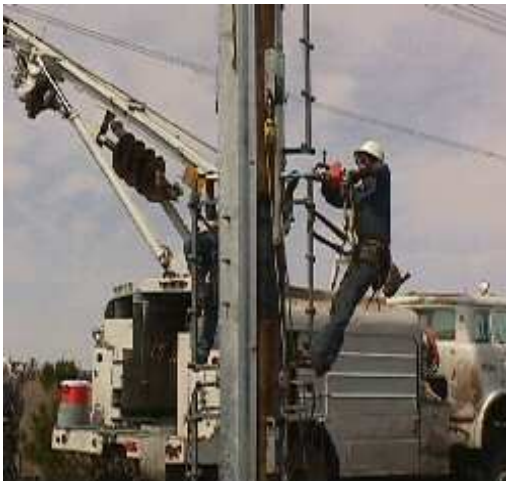
A utility identifies the need to increase the capacity of a key transmission path. A preliminary assessment of limiting factors shows that the ampacity of a 345 kV line built in the mid-1960s is thermally limited by ground clearance due to conductor sag occurring at higher operating temperatures. A detailed line rating study is initiated to identify cost-effective means to uprate the capacity of the line. Hardcopies of original plan and profile drawings are scanned and imported into state-of-the-art transmission line modeling and design software to perform an initial assessment of limiting factors, next LIDAR is used to enable refinement of the line model, and the model is then used to identify the number of spans with inadequate ground clearances, the degree to which ground clearances are exceeded within these spans, and possible means to increase the clearances. Analyses revealed that only a relatively small number of spans within the 156 mile long line exceeded the governing safety code imposed ground clearance limits at the target operating temperatures. Several options were identified for increasing the clearances. These options included replacing existing structures or poles with new taller structures or poles in critical locations, inserting additional structures in critical spans, resagging short sections of the line, or using an innovative technology that enables the heights of existing wood pole structures to be increased in place. Raising the existing structures was determined to be the most cost-effective option for this situation. Implementation of this option resulted in approximately 50% savings relative to the next most favourable option, and enabled a 25% increase in line capacity to be realized within a very tight schedule (18 months from design to completion). In addition, the line remained energized throughout the entire structure raising operation.

Installation of System to Raise Structure

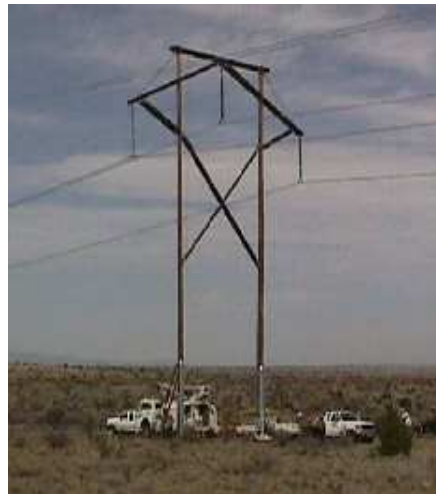
Raised Structure

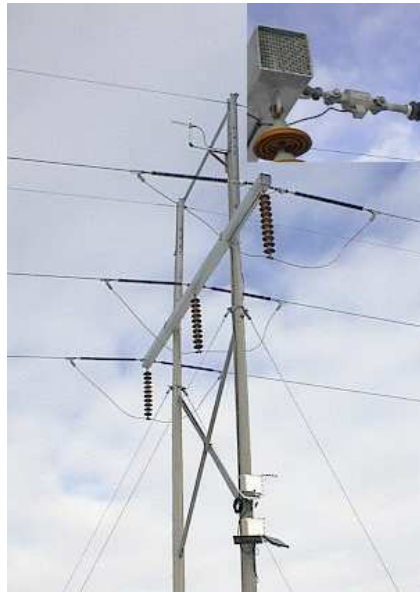
Figure 4-7: Conductor Tension Monitor

The tension or sag monitors are mounted on selected tension structures along the transmission line. At each location, the conductor's mechanical tension or sag is measured by a tension sensor or sag sensor, respectively. A conductor tension monitor is illustrated in Figure 4-7. A conductor sag sensor is illustrated in Figure 4-8.

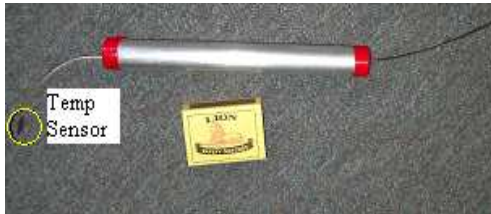
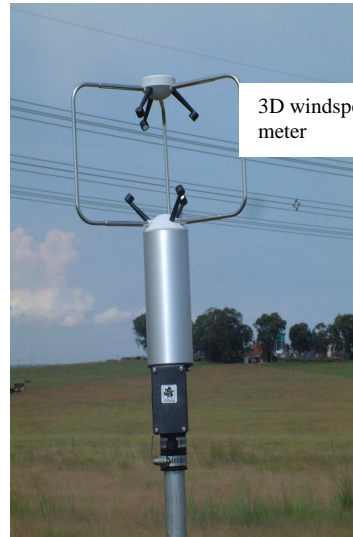
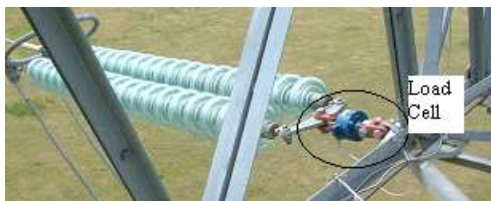
The RETMOS consists of:

- i. For a wind speed of 6.4m/s (23 km/h) at an angle of 36 degrees to the line , an ambient temperature of 6.86 °C and with an electrical load of 2850 A on 2 bundle Dinosaur (54/19 3.95/3.27) phase conductor – the RETMOS measured a phase conductor temperature of 45 °C.
- ii. When the wind speed dropped to 3 m/s (10.8 km/h) for a period greater than 30 min, the temperature of the phase conductor rose to 63 °C..
- iii. When the wind speed dropped to 2 m/s (7.2 km/h) for a period greater than 30 min, the temperature of the phase conductor rose to 79 °C..
- iv. When the wind blew along the line and the sun was at full brightness – the phase conductor temperature rose to 135 °C.

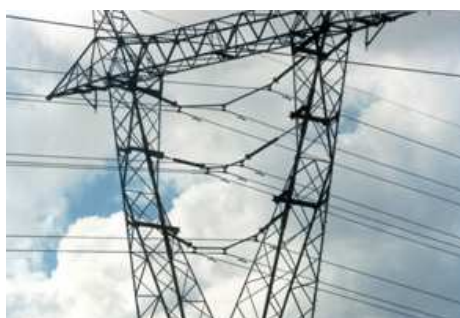
Figure 4-10: 230 kV Experimental HSILL Transmission Line

In summary, HSILL technology enables the design of transmission line configurations that optimises electric and magnetic field distributions and consequently the electrical parameters and the power transmission capacity of the line, as well as the current sharing among different lines in the system.

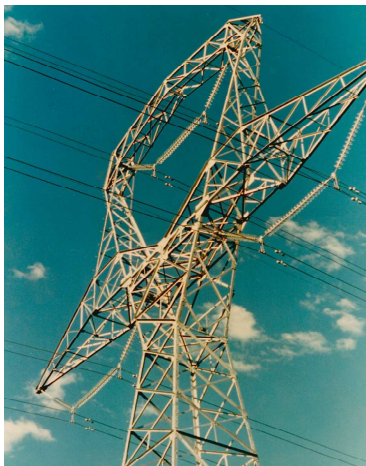
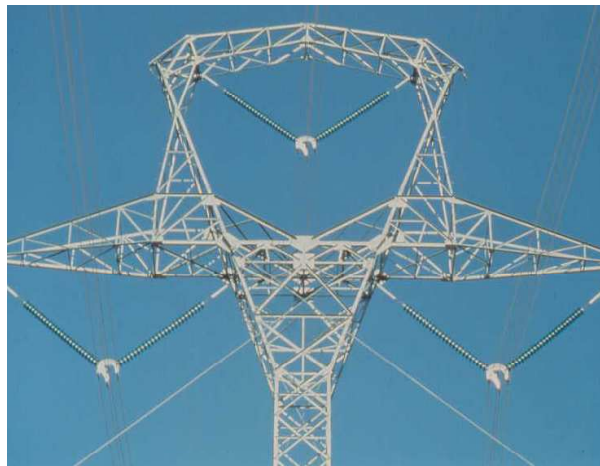
Case study 4-17 (USA): 230 kV to 500 kV Voltage Uprating

This transmission line was originally designed as a single circuit 500 kV line. It was first built as a double circuit twin bundle 230 kV line shown at the left. Several years later it was converted to the single circuit quad bundle 500 kV line on the right. The conductors from the vertical twin bundle were brought together to form the quad bundle and the insulators in the 230 kV “U-string” assembly were split in the middle of the “U” to form the 500 kV “V-string” assembly.

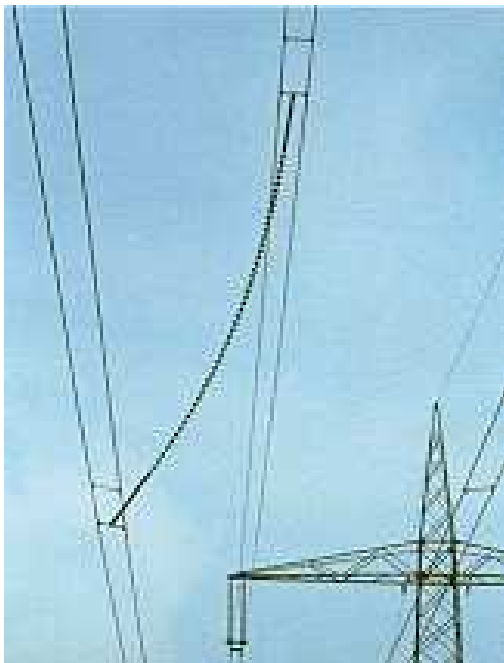
Case Study 4-25 (Germany) – Upgrading from 245 kV to 420 kV by Changing Insulator Sets and Using In-span Insulator Sets

For system voltage upgrading existing tower structures were used. Crossarm dimensions were therefore limited due to restrictions concerning the total line width. Limiting swing of the insulator sets was one of the main aspects to maintain clearances to meet 420 kV insulation levels in accordance with regulations. The former 245 kV insulation consists of double I-string insulator sets with 2 porcelain longrod insulators units in each string.

The first part of the upgrading was to use inverted V-string insulator sets and Y-string set configuration to meet the clearance requirements. Twin 30.5 mm diameter ACSR conductor bundle were used. Transmission capacity was upgraded from 230 MW to 470 MW per circuit.

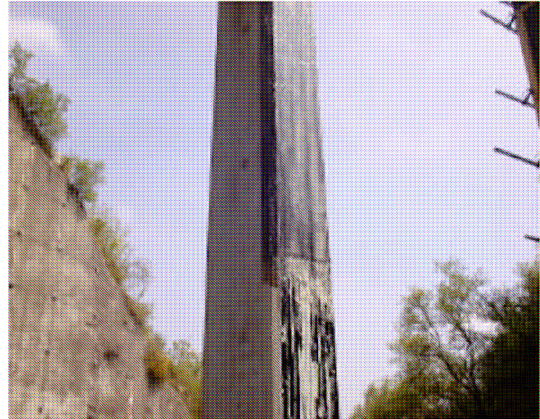
Example of light reinforcement: the concrete pole is reinforced along its profile side to increase the overhead line withstand to transversal loads.

A carbon fibre coating is applied on the total height of the pole

- i. For a light reinforcement: carbon fibre sticking on all the height of the pole (see picture)
- ii. For a heavy reinforcement: addition of a new belt on the existing pole. This “belt” can be made up of reinforced concrete or fibre-reinforced concrete systems (with in this case a reduced thickness)

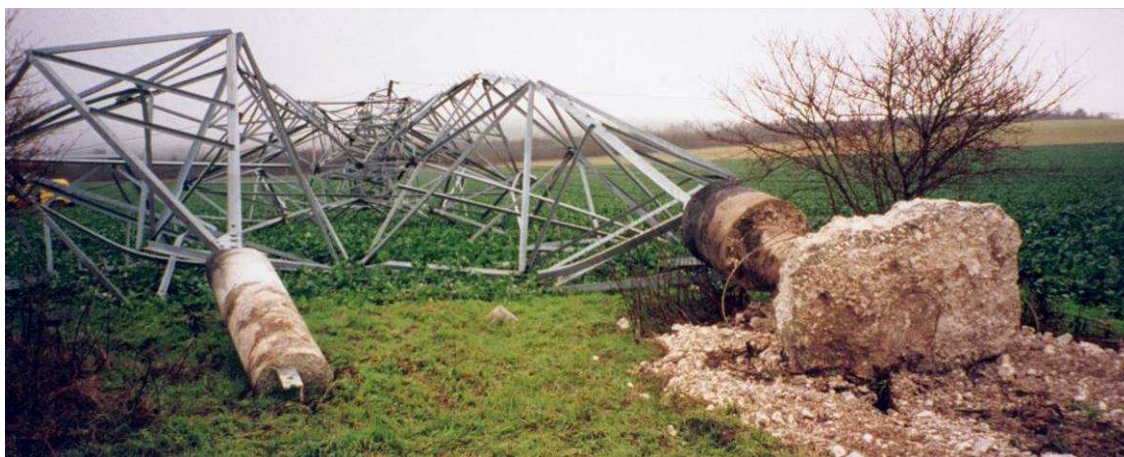
Figure 5-1: Foundation Failure after Windstorm

- i. Wind loadings;
- ii. Snow- and ice load
- iii. Landslides;
- iv. Snow creep.

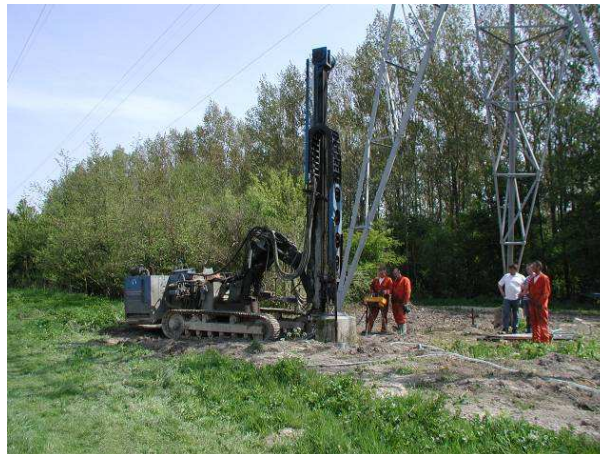
Figure 5-2: Equipment for upgrading foundations

Depending on the size of equipment used for upgrading it could be necessary to deenergize the overhead line. When it is not possible to deenergize the overhead line or the outage time is limited then there decision is made to redesign the upgrading with using smaller equipment. One should also be aware of the time necessary for upgrading the foundation and the outage availability

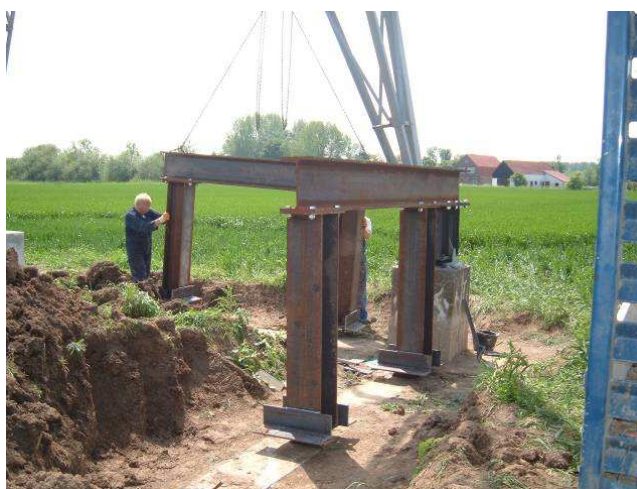
Figure 5-7: Use of Temporary Construction to Take Over Foundation Loads

The use of temporary construction will have great effect on the costs of upgrading the foundation.

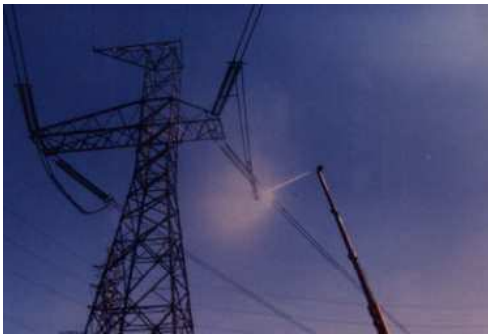
Above, typical insulator washing on +/- 500kV DC and 230kV lines

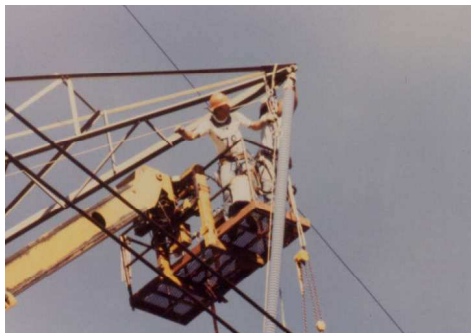
At left, change out of 230kV ceramic insulators with Non-ceramic insulators. Since installation no washing has been required.

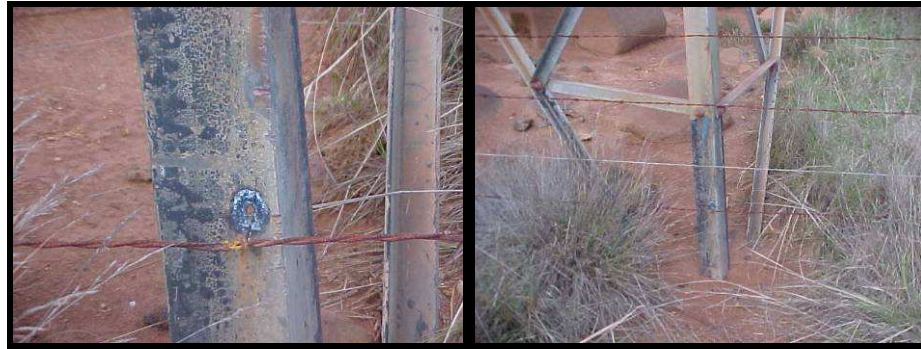
Figure 5-10: Typical Evidence of Structure Potential Rise and Flashover to Adjacent Metallic Fence

A typical example is shown in Figure 5-10 where the structure earthing was very high and the lightning current flashed over to an adjacent fence.

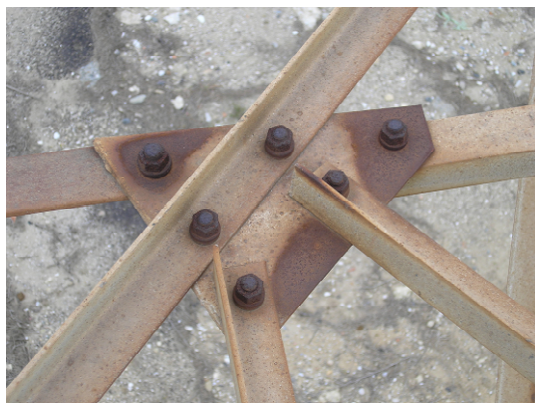
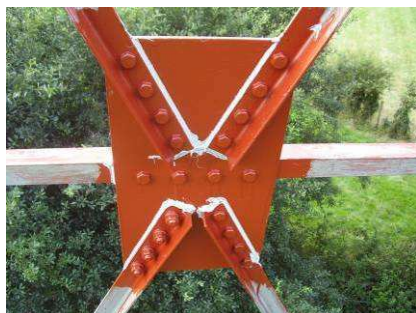
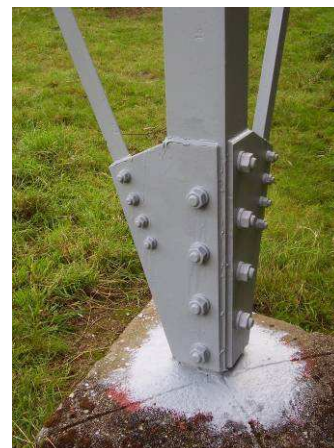
Case Study 6-1 (Spain) – Painting of 400 kV Towers

A line with 32 years in mountainous and humid area. Inspection detected extensive corrosion. A special corrosion study was performed in order to determine the losses of material. The study concluded that material was not significant as to effect the strength, so painting was decided. 85 towers were painted in 15 days. Two layers of paint was applied.

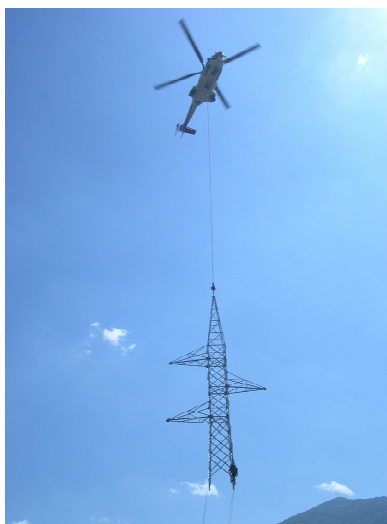
Case Study 6-2 (Spain) – Replacement of 220 kV Towers

A line with 50 years in mountainous and humid area. Inspection detected extensive corrosion. Special corrosion study was performed in order to determine losses of material. Study concluded that there were high quantities of lost material in different bars, legs and bracket plates. Therefore replacement of towers was necessary.

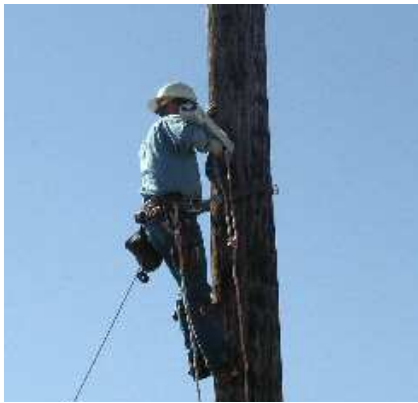
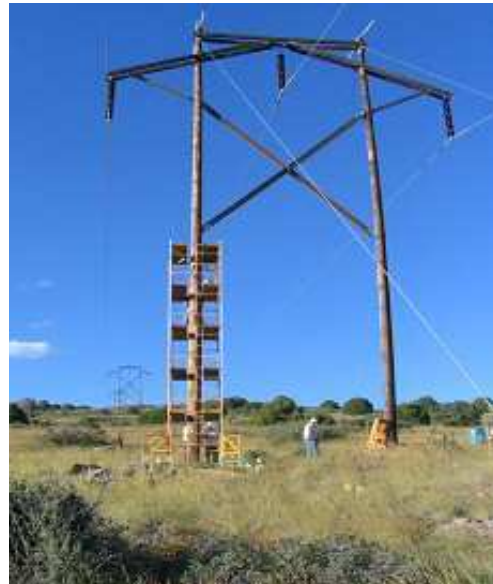
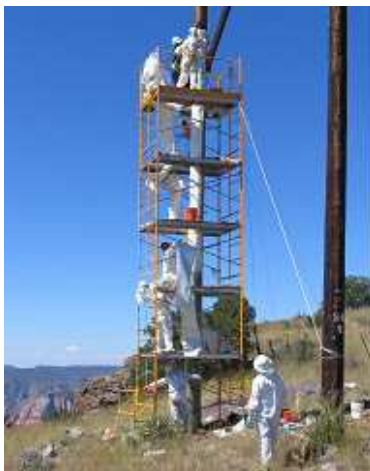
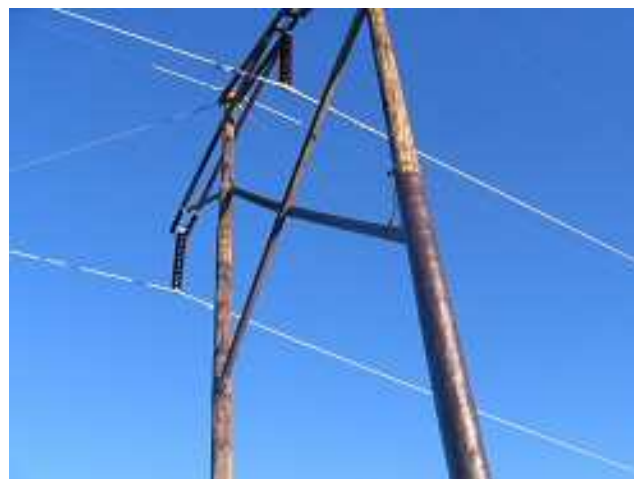
Case Study 6-4 (USA) – Reinforcement of 230 kV Wood Pole K-Frame

A line patrol identifies that a 56 year old wood pole located in a remote mountainous area has been severely damaged by woodpeckers and decay, and is in danger of failing. The line is critical to system reliability. It is not practical to schedule an extended outage in the near future to enable the necessary repairs to be performed using de-energized work practices. The damaged structure is located in an environmentally sensitive area on federal lands therefore, special access roads would need to be permitted and constructed to enable line trucks to drive to the structure in order to replace the pole. For these reasons pole replacement was deemed to be cost prohibitive. Hence, a follow up inspection was performed in which detailed measurements were made that were then used as input for structural analyses to assess the feasibility of restoring strength to the damaged pole using a field applied composite reinforcement technology. The assessment indicated that adequate strength could be restored using a patented composite repair consisting of a fibreglass wrap coupled with a phenolic resin system designed specifically for restoring strength to wood poles. The pole was then thoroughly treated with preservatives to minimize further decay, and a repair was then designed and installed over a four day period with the line energized at a substantial cost savings relative to pole replacement.

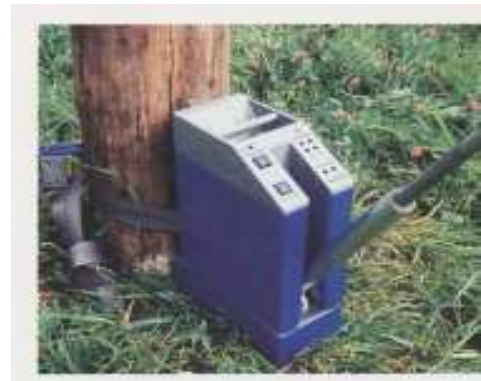
Control of embedding with the support of a dedicated tool: on this picture, the polux device, used to analyse the residual wood properties

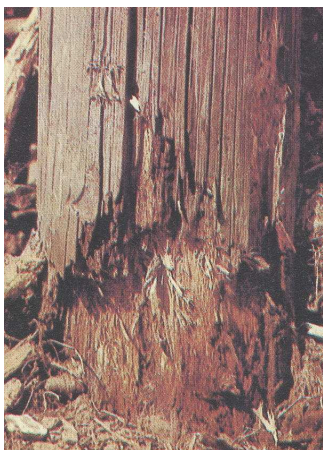
Typical deterioration of a wooden pole: caused either by natural ageing of external aggression (engines, tools used in the vicinity of the pole, woodpecker)

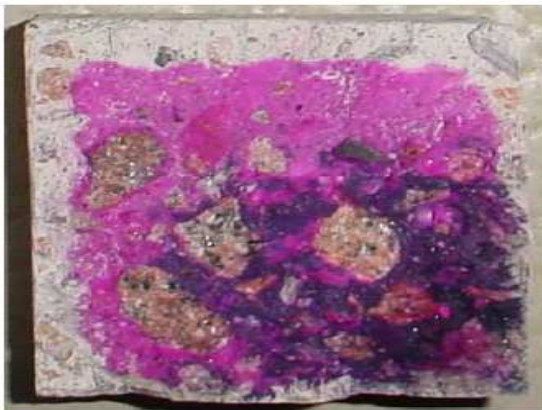
Carbonation can be visualized by using phenolphthalein.

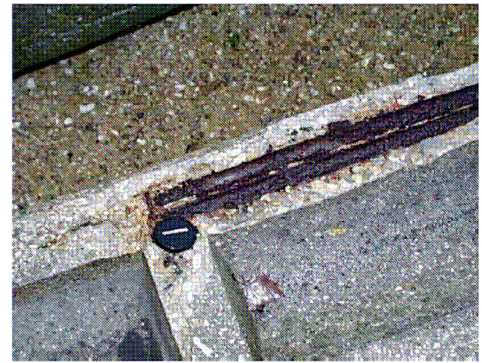
**Typical pathology on concrete poles :
outer part of concrete damaged as a
consequence of a corrosion process on
steel reinforcing bars**

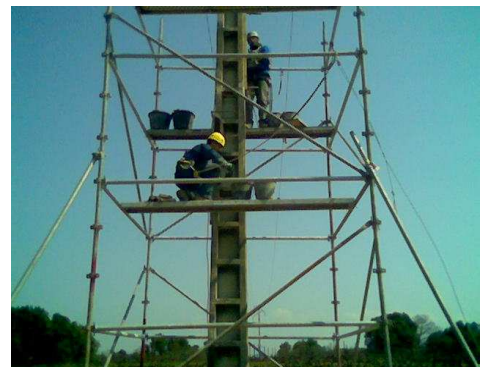
**scaffolding installed to facilitate the
repair works on a damaged pole**

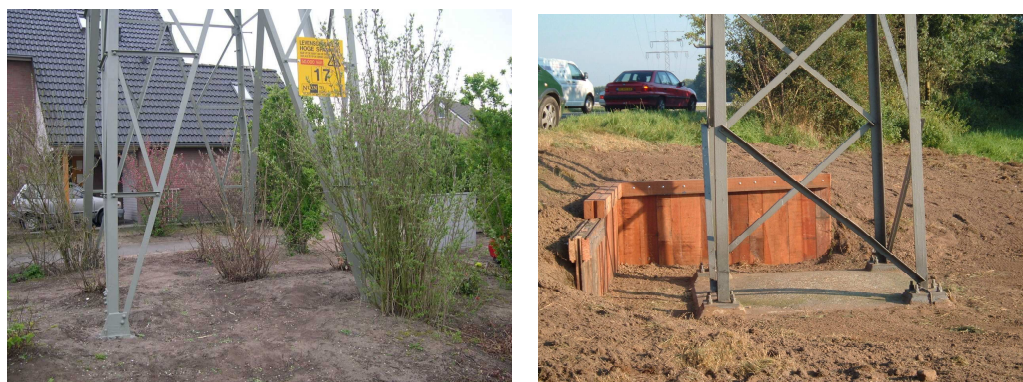
Figure 6-5: Changes of Environment (e.g Raising Soil Around Foundations) will Lead to Refurbishment of Foundations or Soil near Foundations

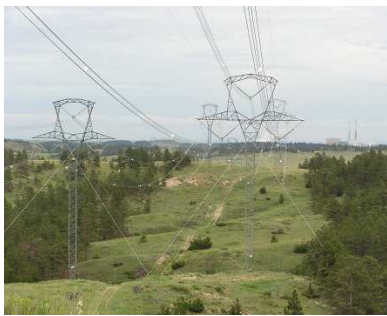
Anchor rod with grout exposed from erosion

Sixteen years after construction, anchor rods in two parallel 500 kV lines began to fail due to corrosion occurring at 2-5m below ground; within twelve months of the first failure two additional failures occurred. The lines were constructed using guyed-delta towers and a total of approximately 6400 anchors were installed to support the towers. The combined length of the lines is about 800km. Replacement of all the anchors was not economically feasible; however, no test method was available at the time that could be used to detect which anchor rods may be at risk of failure. Therefore, a research project was initiated which led to the successful development of an ultrasonic nondestructive evaluation (NDE) technique that could distinguish severely corroded anchors from intact rods. The inspection technique was then applied to identify rods requiring replacement and an inspection program was initiated that requires reinspection of all anchor rods every five years. A rigorous program for managing the cathodic protection system for the line and maintaining sacrificial anodes was also implemented. Anchor rods found through NDE to be severely corroded were replaced with pier foundation tie-downs to support the guy wires. The asset owner is investigating the potential for using a new composite anchor rod for future replacements due to their lower cost relative to the pier foundations.

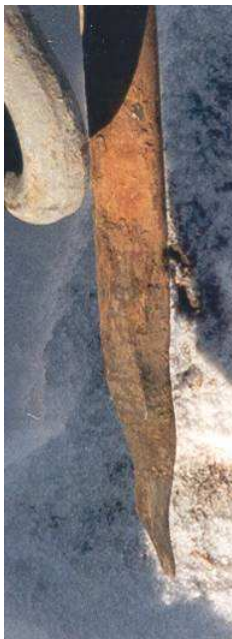
Failed anchor rod (5m below ground)

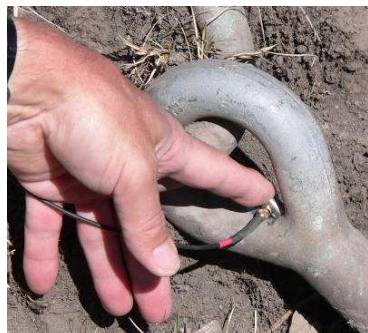
Ultrasonic NDE sensor placed in anchor rod eye

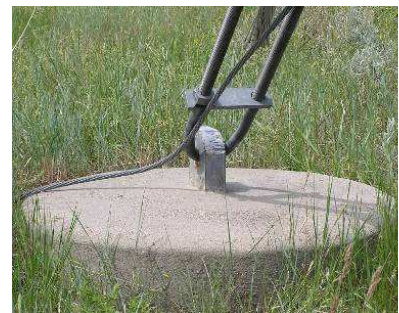
Pier foundation replacement for corroded anchor rods

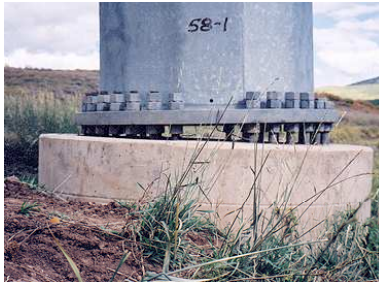
Figure 1: A close up of Structure showing how much the anchor bolts have been adjusted to compensate for the shifting ground due to landslide

Steel pole structure No. 58/1 on the Curecanti – Rifle 230 kV line in Grand Mesa National Forest, Colorado, USA, was installed in 1984 to replace a lattice tower destroyed by a landslide. A continuing landslide, which affected the entire surrounding landscape, over a period of 19 years, slowly tilted the approx 14 meter deep reinforced concrete drilled shaft foundation approximately 6 degrees from its original plumb position. During that period, the 28 anchor bolts each with a 1335kN capacity, that secured the pole base were adjusted a total of 200 mm to compensate for the pole’s changing position – 100 mm on the uphill side and 100 mm on the downhill side. Figure 1 shows a close up of how much the anchor bolts have been adjusted to compensate for the shifting ground.

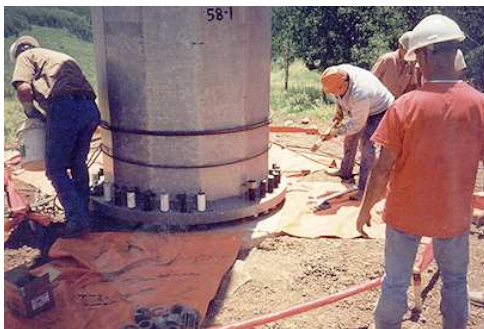
Figure 2: Crew Members remove bolts and place PVC pipe segment over the bolt threads to protect them from damage when structure is lifted off the foundation.

To correct the situation, a base leveler was designed to compensate for angle difference between the pole and the top of the foundation. The leveler is a wedge shaped steel tube with 100 mm thick flange plates that attaches directly between the existing foundation and the structure base. Figures 2-4 show the installation of leveler and the installation of the structure on the new level foundation.

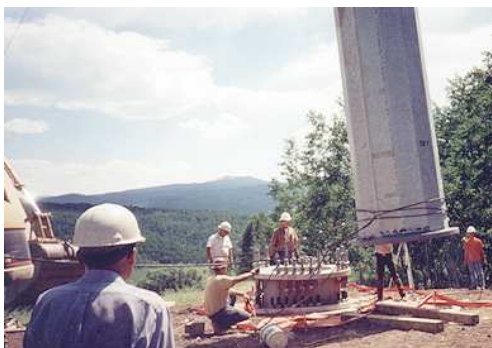
Figure 4: Structure is manoeuvred onto the leveler

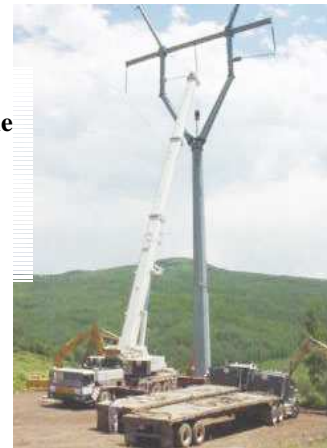
Figure 3: A crane Lifts the Structure, with conductors attached, off its foundation

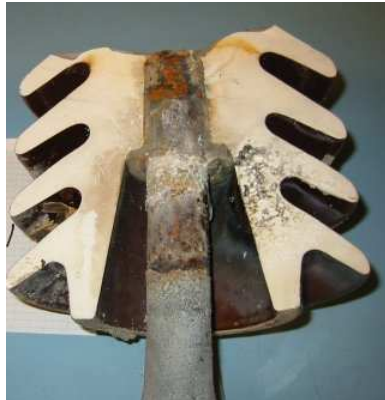
Figure 6-7: Corrosion on a Support Insulator

Fittings (hardware of insulator strings as well as end fittings of insulators) are usually made of ferrous metal or aluminium alloy. Corrosion is the cause of metal parts deterioration and hot dip galvanizing is typically used to resist or prevent such deterioration. The aluminium alloy hardware can wear out due to vibration, loss of material strength or electrolytic corrosion that can result in failure.

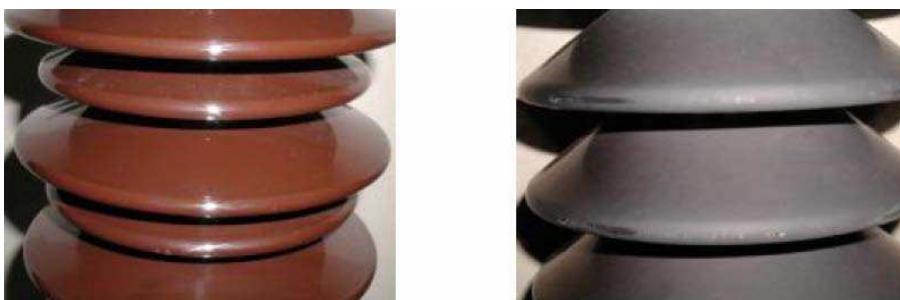
Figure 6-8: A new ceramic insulator on the left and a ceramic insulator after 30 years in operation on the right – glazing of the surface is damaged, the surface is rough and different kinds of fungi contribute to it's deterioration. Consequently leakage distance of such insulator has decreased due to increased conductivity of the surface and a number of flashovers have occurred.

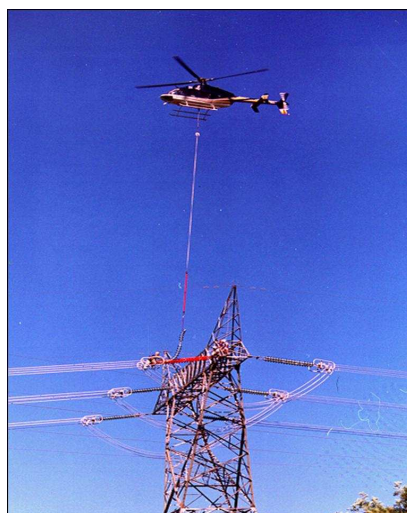
Figure 6-10: Replacing Faulty Insulator in a Dead-End Insulator String, Live Line Maintenance is Used

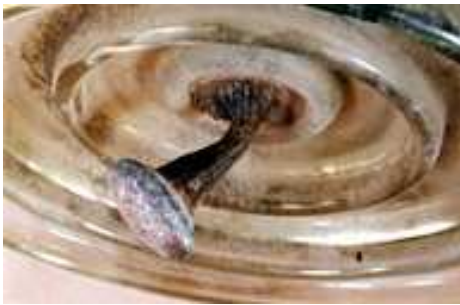
Contaminated and wet insulators display a biased leakage current having DC component. This DC component causes electrolytic corrosion and reduction of pin diameter, as shown in the figure

Cap and pin insulators have a limited service life, mainly due to corrosion of the galvanized steel pin. These pins are very susceptible to corrosion in marine or polluted environments due to the high electric fields at the energized end of the string. The corrosion will result in loss of pin diameter (see Figure) and strength and possible cracking and puncture of the insulator between cap and pin.

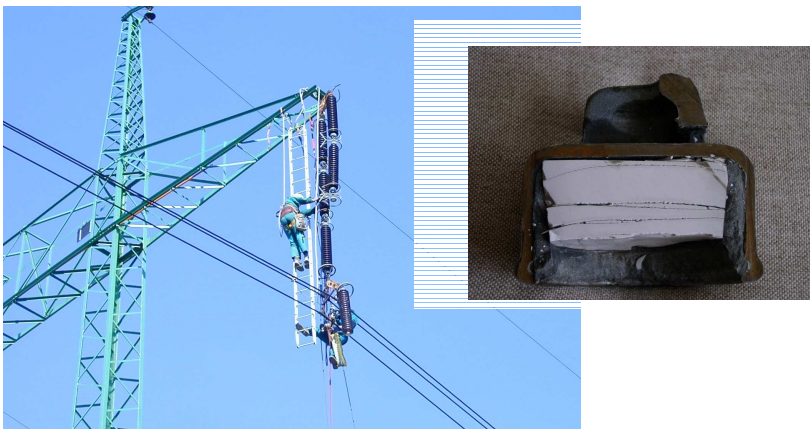
The first crack initiates on the perimeter of the insulator head mounted in the metal armature close to the upper end. This peripheral crack grows into the bulk of the ceramic up to complete peeling off of a slice of material. Then the new crack initiates in the remaining part of the insulator head and the process repeats itself until the lower part of insulator head cementing is reached and final insulator failure occurs.

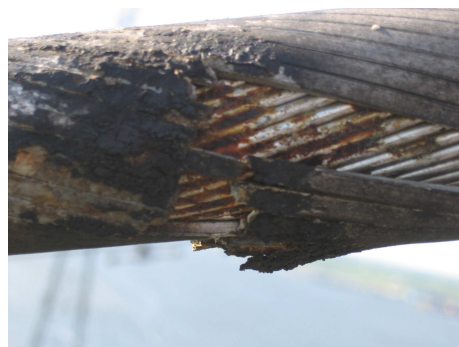
Figure 6-11: Broken Wires Due to Corrosion and Corrosion Fatigue Beneath a Damper

In the case of ACSR conductors corrosion leads to loss of steel galvanization in steel core wires. This is followed by galvanic corrosion between steel and aluminium wires attacking most aluminium strands in the inmost layers. Another mode of failure affecting all kinds of conductors is crevice corrosion that may occur beneath connectors, clamps, XLPE-insulation on covered conductors etc. Crevice corrosion usually attacks locally but in some cases it may diverge along the conductor if its spaces and crevices are not filled with grease.

Mending of the decay may be carried out by repair rods, but ac-corrosion and arcing may occur also beneath the rods due to their inability to short-circuit the coupling between the damaged and undamaged wires.

A combination of repair rods and shunting or a repair sleeve compressed outside the decay will take care of the mechanical and electrical properties of the conductor. However, there is a possibility that the continual corrosion will expand.

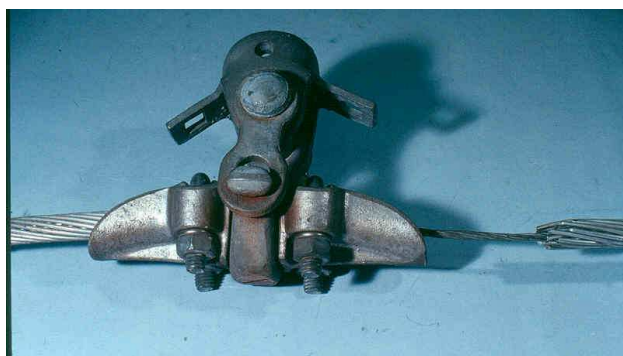
Figure 6-12: Fatigue has Lead to Broken Wires in a Supporting Clamp Due to Vibration

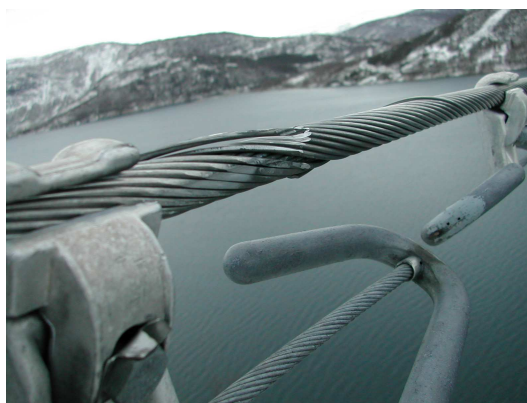
Figure 6-13: Wear and Broken Wires Due to a Loose Damper

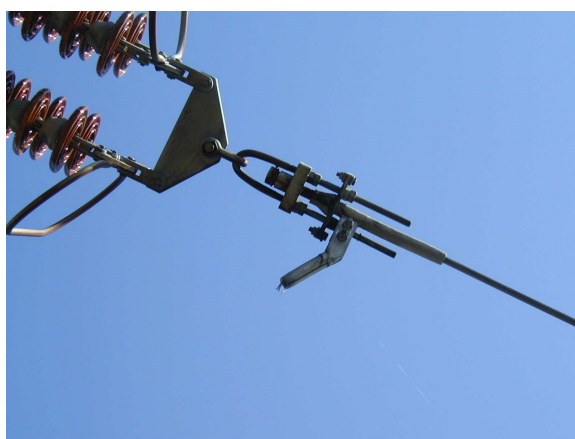
Figure 6-14: A Swinging Jumper has Lead to a Broken Conductor Adjacent to a Dead End Tension Joint

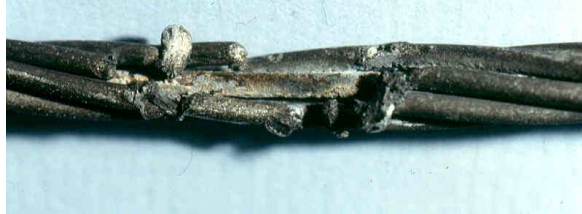
Figure 6-15: Clashing Conductors or Lightning Strokes may Lead to Electric Arc Burn

- ii. Clashing conductors may lead to electric arc burn. This may occur in strong wind, during galloping or ice shedding.
Phase spacers are used to eliminate conductor clashing.

- iii. Lightning strikes, either direct or indirect, may give rise to electric arc burn which can be due to improper arcing and over-voltage protection or faulty conductor selection.
Lightning problems can be avoided by the proper selection of arcing devices and, e.g. in case of OPGW, by choosing a conductor suitable for heavy lightning density areas.

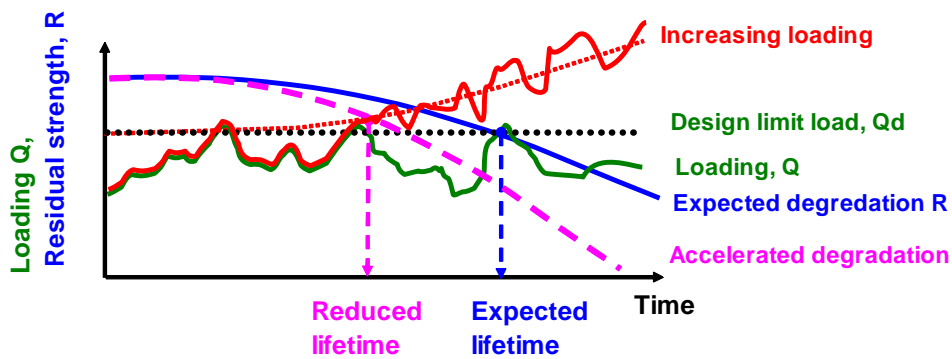
Figure 6-17: Reduced Life Time and Need for Upgrading Due to Climatic Change

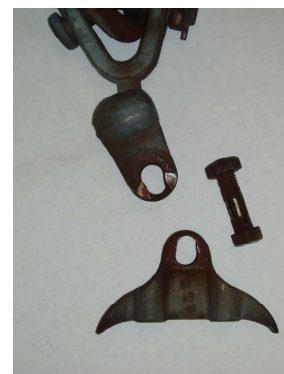
During normal inspection, several assemblies were found to have severe wear. These assemblies were replaced and tested. The results indicated a change out of all assemblies in areas of high nominal wind speed

Since overhead ground wire suspension assemblies are much shorter than phase insulator and hardware assemblies, wind induced wire motion, normally causes greater motion and therefore more wear on the overhead ground wire assemblies.

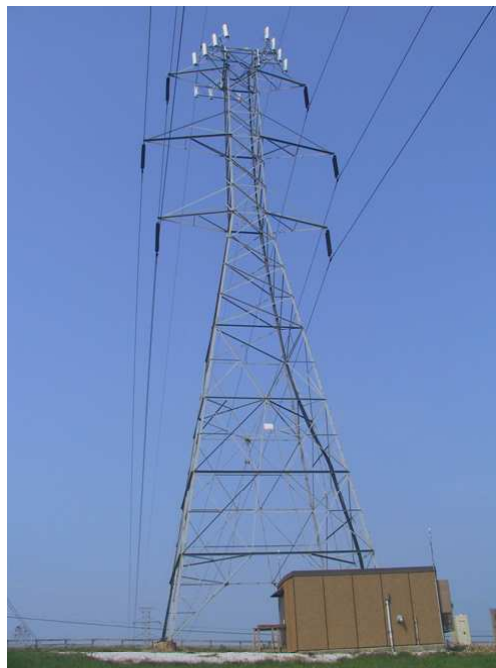
Figure 7-1: Direct mount of telecommunications antenna to a double circuit 230 kV lattice tower between shield wire and top conductor arm. Note location of communication control building and coax cable installed on cable ladder.

A minimum of three antennas located 120° apart are required for each carrier. There may be as many as four antennas located in each sector. Amplifiers may be required for each antenna. One or two coax cables are attached to each antenna and run down the structure to a control cabinet or enclosure which can be located on the ground (Figure 7-1 close to the tower or inside the main legs) or on a special platform. Service voltage electricity supply is necessary (usually supplied from an external source).
