**GUIDELINES FOR INCREASED UTILIZATION
OF
EXISTING OVERHEAD TRANSMISSION LINES**

**Working Group
B2.13**

August 2008

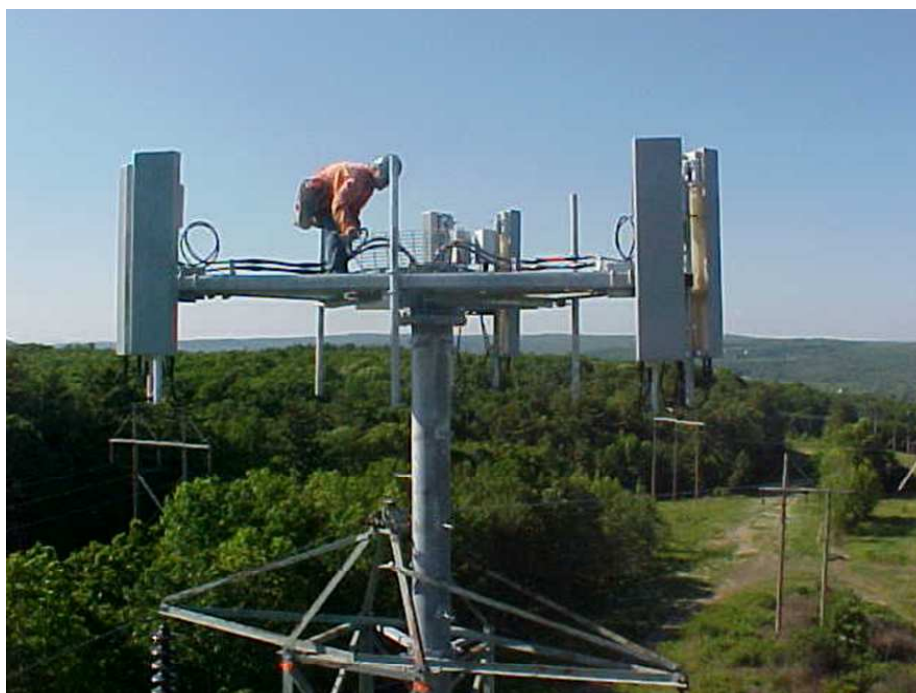
Figure 7-2: Worker on pipe extension to a double circuit 115 kV lattice steel tower with antenna mount platform

- i. The optimal elevation of the antennas is determined by the cellular engineer to obtain maximum signal coverage. Antennas can be mounted below or above phase conductors or on the top of a tower above the earth wire (if any). If the elevation is below the top of the structure, the antennas are mounted directly on the structure. If the elevation is above the top of the structure, an extension is designed to support the antennas at the required elevation (Figure 7-2);

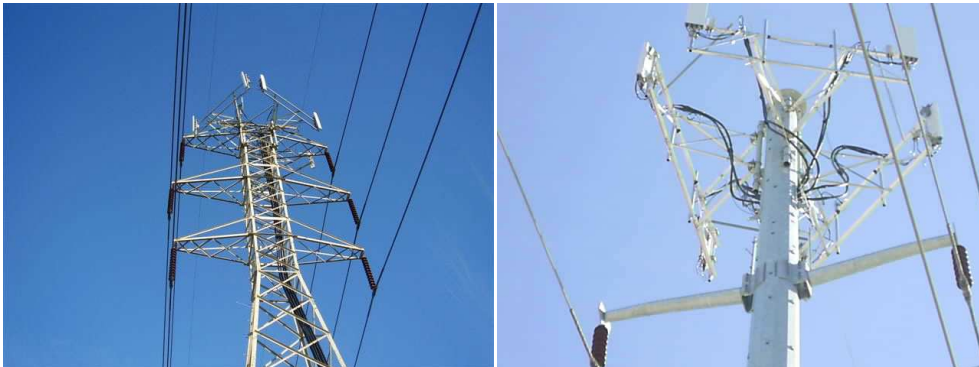
Since the introduction of personal cell phones in the USA in the late 90's, the use of existing transmission structures has been utilized for location of antennae. Typically, they have been located above the conductors due to the need for height. One arrangement is shown in Figure 1 (typical steel pole and tower). Another arrangement to achieve additional height is to use an auxiliary "pole extension", which extends above the structure (Figure 2). In some cases, there is significant structural reinforcing to incorporate both types (as shown in Figure 2 for the tower). Evaluation of the structures is required, as are detailed engineering design plus specialized crews for construction

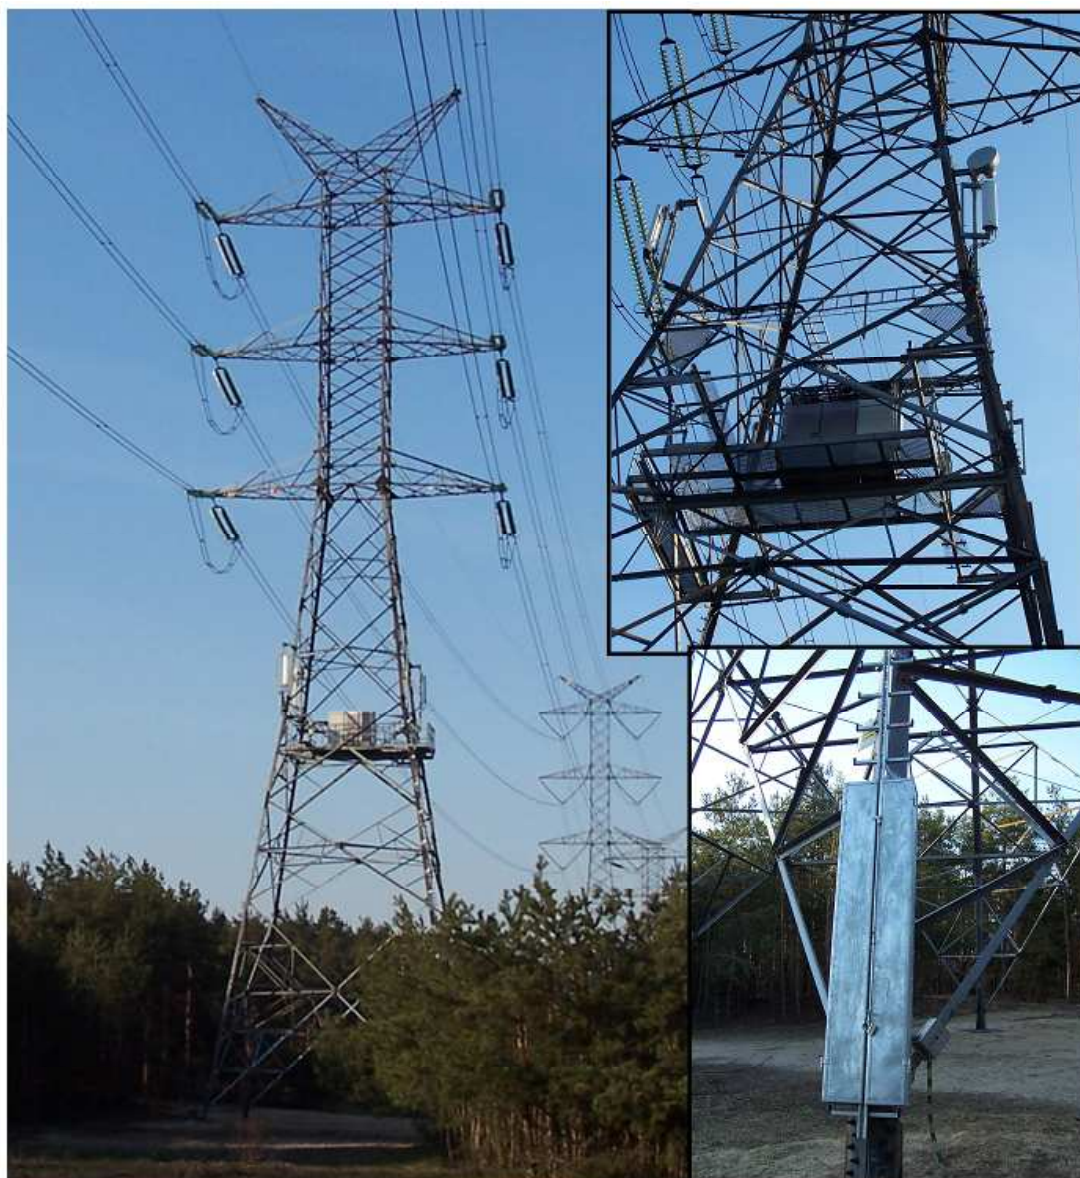
A telecommunication operator was interested in installation of antennas on a 400 kV tower. The operator of a line accepted this location on a condition to locate antennas below the attachment points of phase conductors and in a distance of at least 3.5 meter from live parts. The control container was located on a height of 17 meter. The tower construction was checked for additional loads which resulted in local reinforcement of the tower body. Special platform to carry the container was designed as well as four triangular shaped smaller platforms to enable installation and maintenance of antennas. The tower is typically equipped with climbing steps on one leg, but special ladder was provided for antennas operator staff. In the bottom part this ladder is protected (a key locked cover) from climbing by unwanted persons. Electricity supply is provided by the low voltage cable. The installation has its own grounding system.

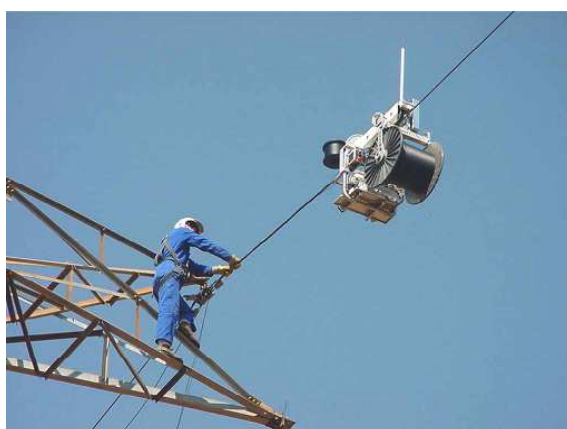
ADL, both hand and motor lash techniques, was used on 275 and 400 kV transmission lines. In the former technique the lash machine, with its lashing tapes installed, is placed on the earth conductor and pulled along the span with an insulated hand line from ground level. The optic fiber cable is laid out at ground level and is fed up into the lashing machine. The machine is relatively light (30kg) and can be handled by a line worker on the earth peak of a transmission tower. The basic principle of motor lash technique is identical to hand lash except that the remote controlled machine is equipped with a petrol motor that is able to propel it along the span. Due to clearance requirements between earthwire and phase conductor the work could be done live with motor lash technique on 400 kV lines and with hand lash technique on 275 kV lines.

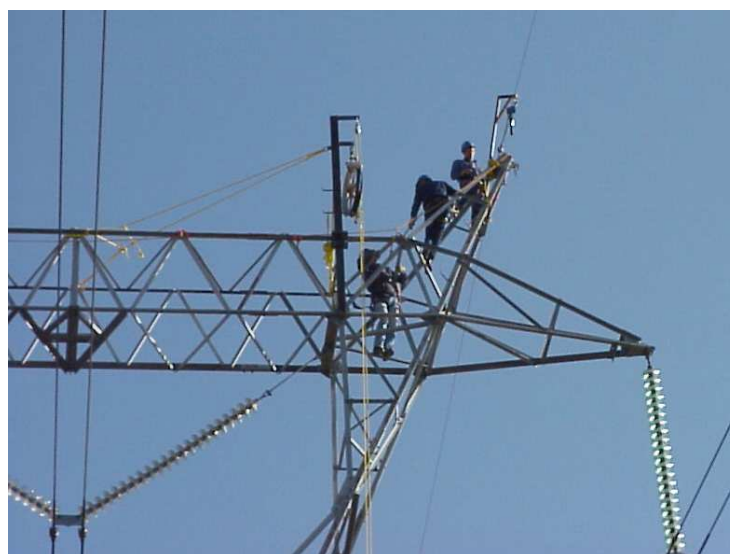
Workers installing optical fibre cable by live line methods

A planned outage is required to install optical fibre cable on existing overhead transmission lines but, sometimes it is impossible to get it due to restrictions of the network. In that cases (approximately 30%) the optical fibre installation was performed by live line techniques. This method consists of stringing of the OPGW to a tension of 80% of the final tension to maintain, at any moment, the necessary safety distances according to the corresponding regulations.
