**BIG STORM EVENTS
WHAT WE HAVE LEARNED**

**Working Group
B2.06**

April 2008

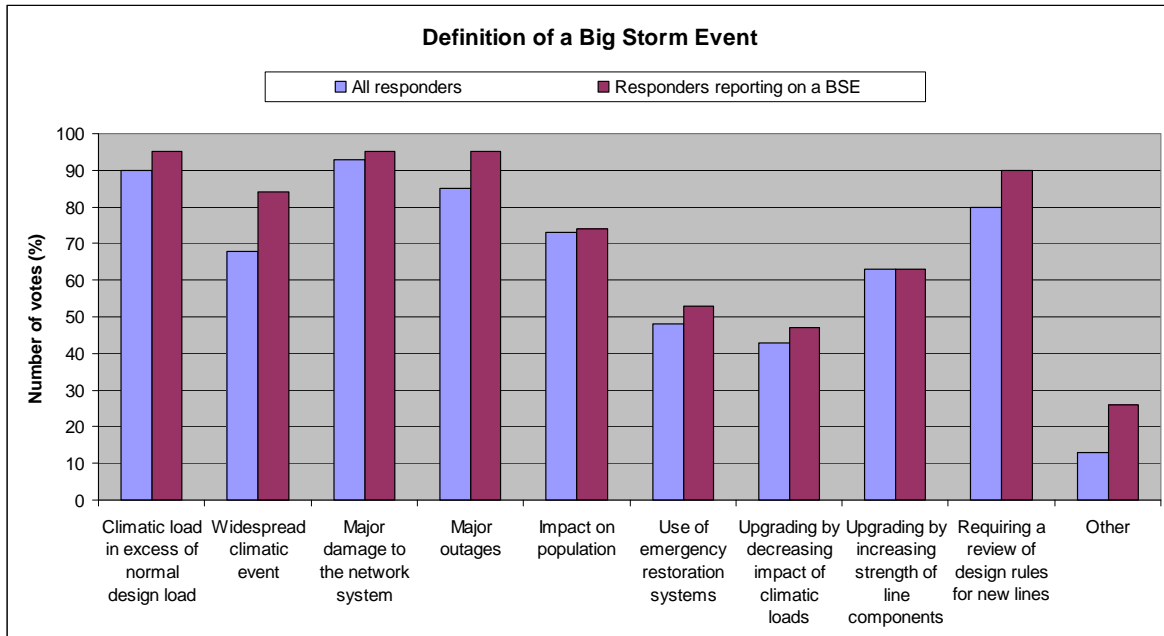
Figure S.1 – Criteria for the definition of a BSE according to all responders and responders reporting on a Big Storm Event

The variety of different views expressed by the responders is illustrated in **Figure S.1**.

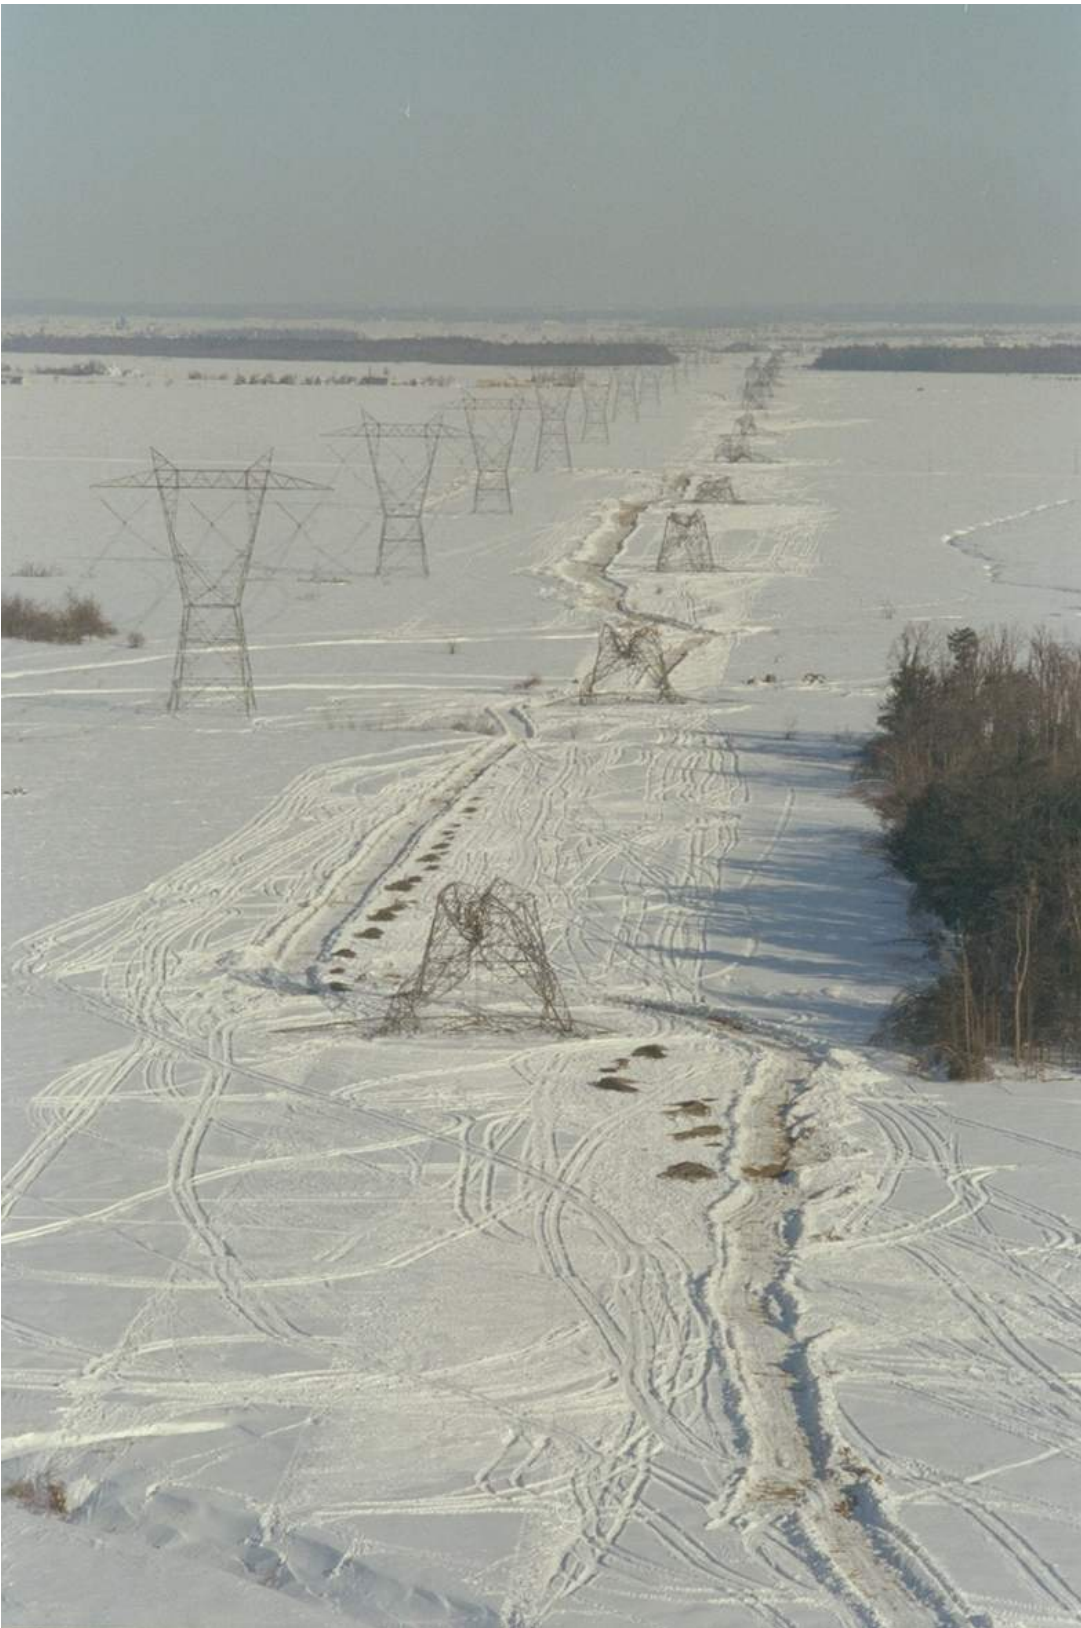
Figure 1 - January 1998 ice storm in Canada (HQ)

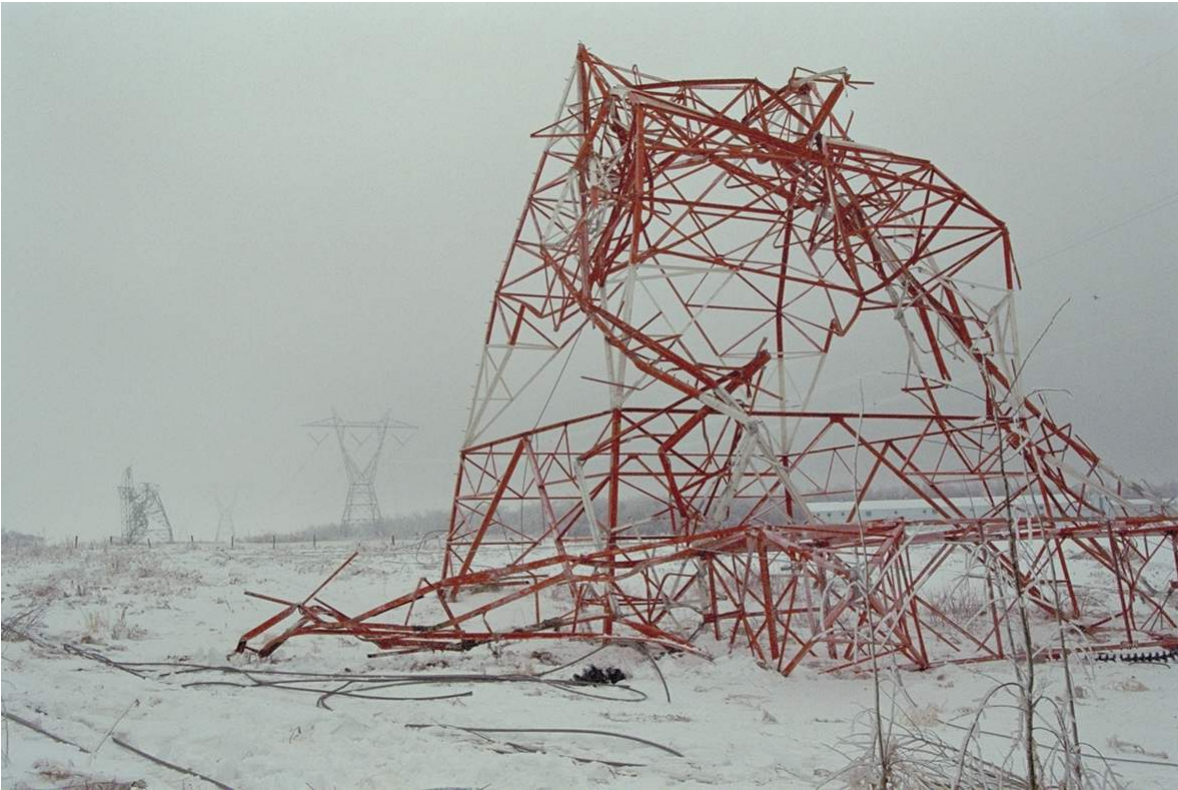
Figure 2 - January 1998 ice storm in Canada (HQ)

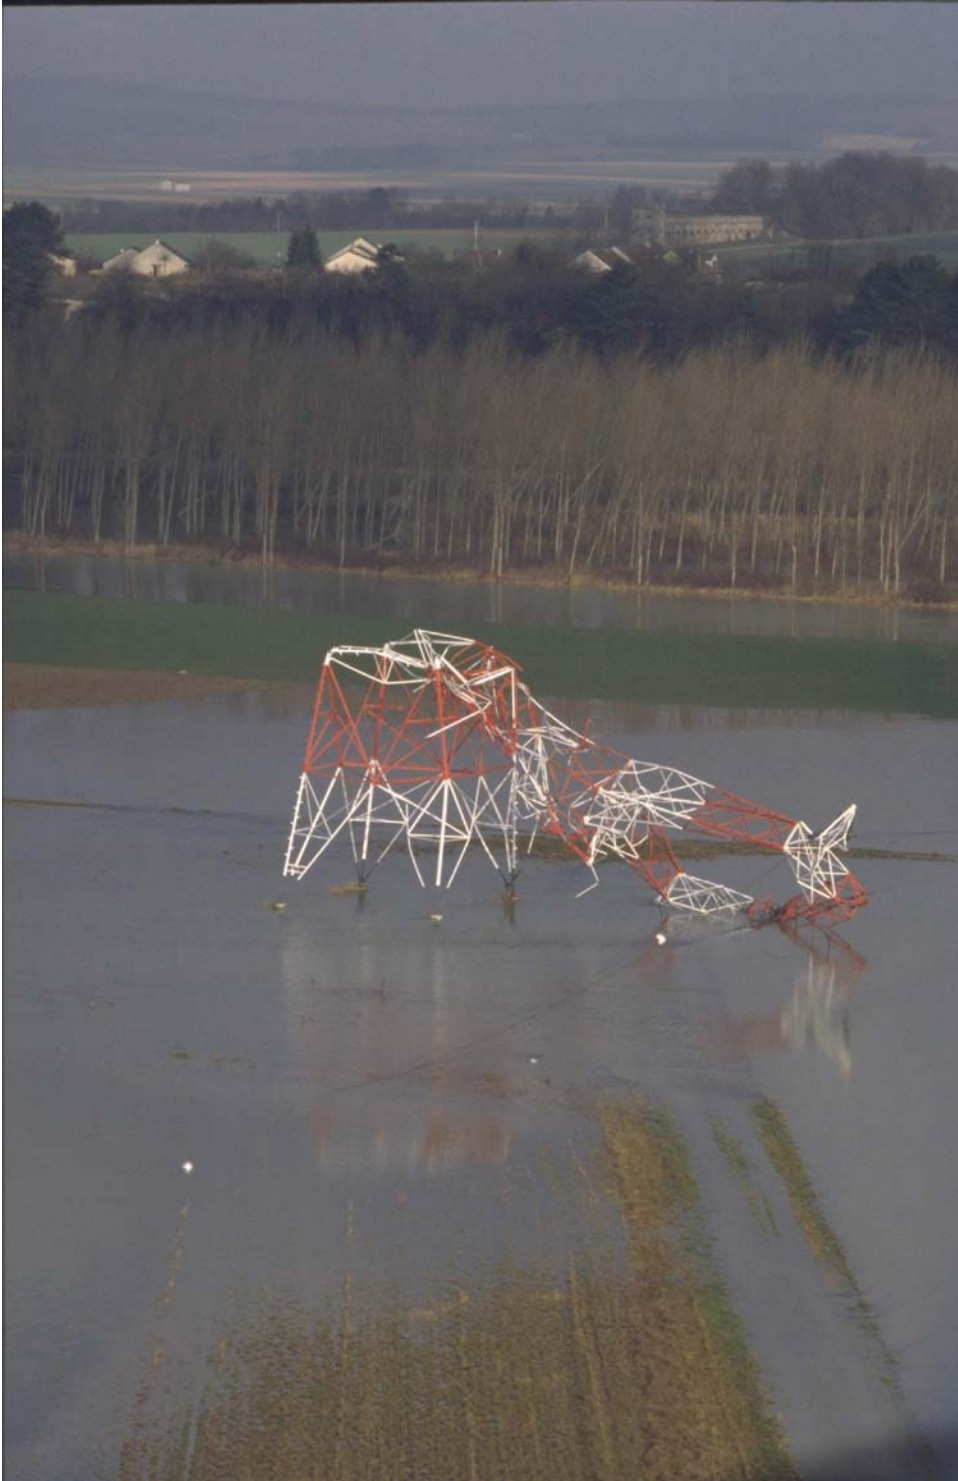
Figure 3 - December 1999 windstorm in France (RTE)

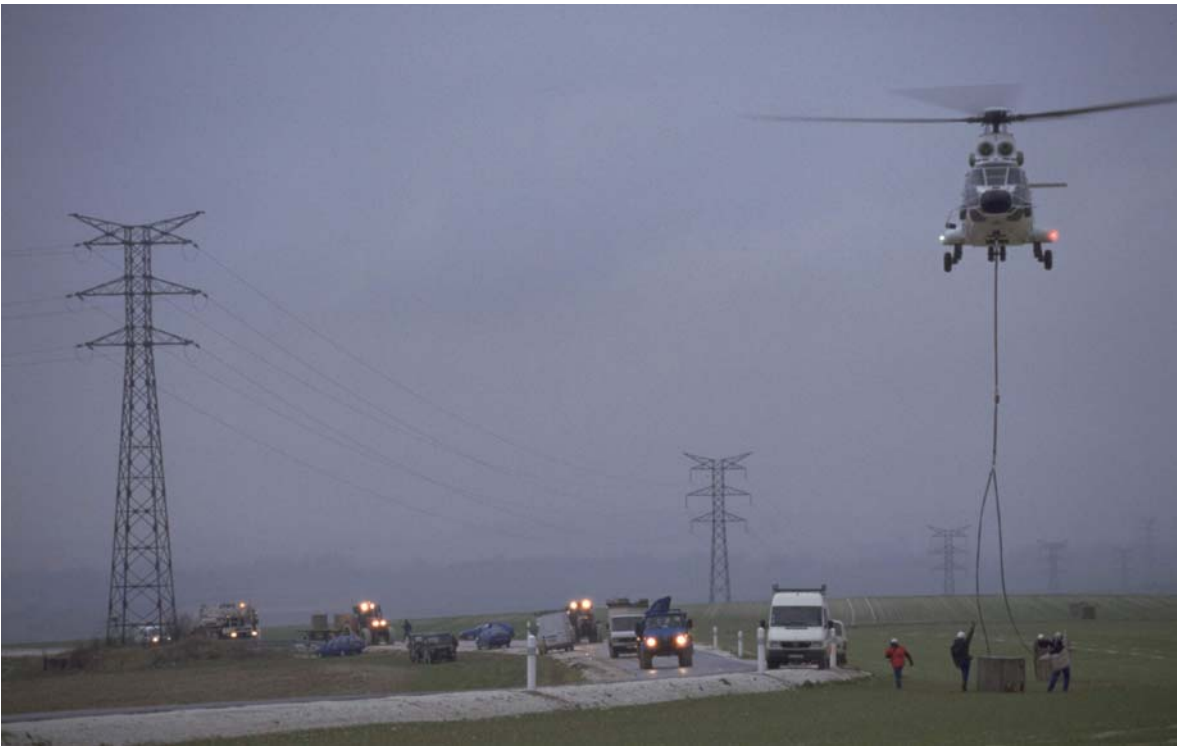
Figure 4 - December 1999 windstorm in France (RTE)

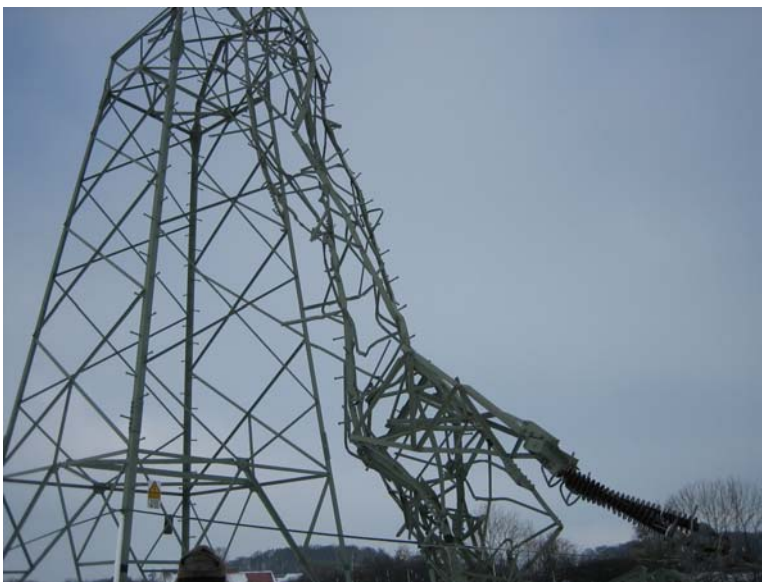
Figure 5 - Wet snow storm on November 24-25, 2005, Germany (E.ON)

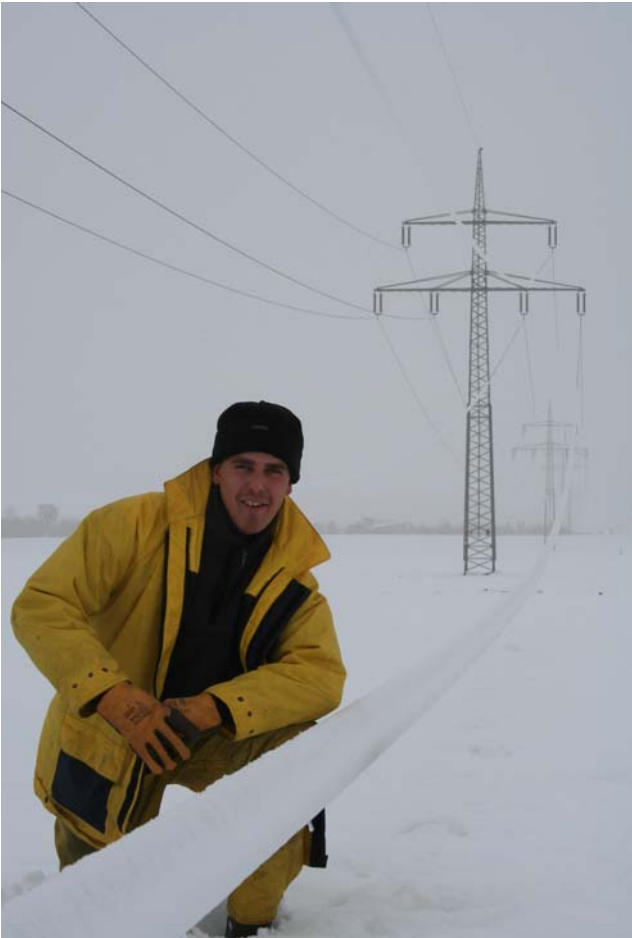
Figure 6 – Snow accretion after the wet snow storm on November 24-25, 2005, Germany (E.ON)
