HVDC Converter Transformers

**Design Review, Test Procedures,
Ageing Evaluation and Reliability in Service**

**Joint Working Group
A2/B4.28**

February 2010

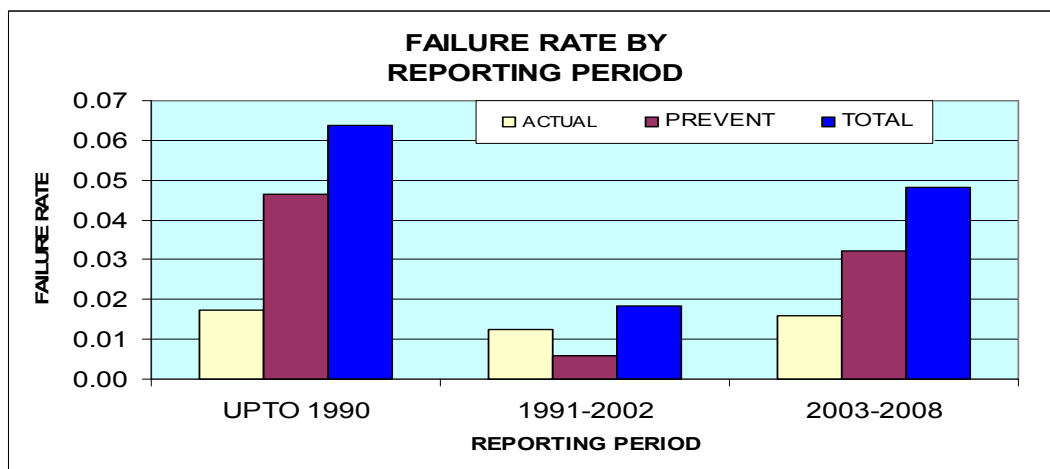
Figure 1. Failure Rate for the period 1972 to 2008 (survey data 2003 to 2008 grouped)

Figure 1. shows the Converter Transformers failure rate history based on the combined data of surveys carried out in the following periods:

It can be observed in the Figure 1. that following a reduced failure rate in the period from 1991 to 2002, there was a significant increase in the period from 2003 to 2008 as derived from the combined data collected through three individual surveys (2003-2004, 2005-2006 and 2007-2008). However, when the failure rate is shown separately for the three individual surveys reported in the period from 2005 to 2009 (Figure 2.) it can be seen that the main contributor to the increased combined failure rate was that corresponding to the period 2003 to 2004. Following this initial rise the rate was monotonously decreasing through the period 2005-2006 and finally dropped to a level below the rate recorded for the period 1991 to 2002.

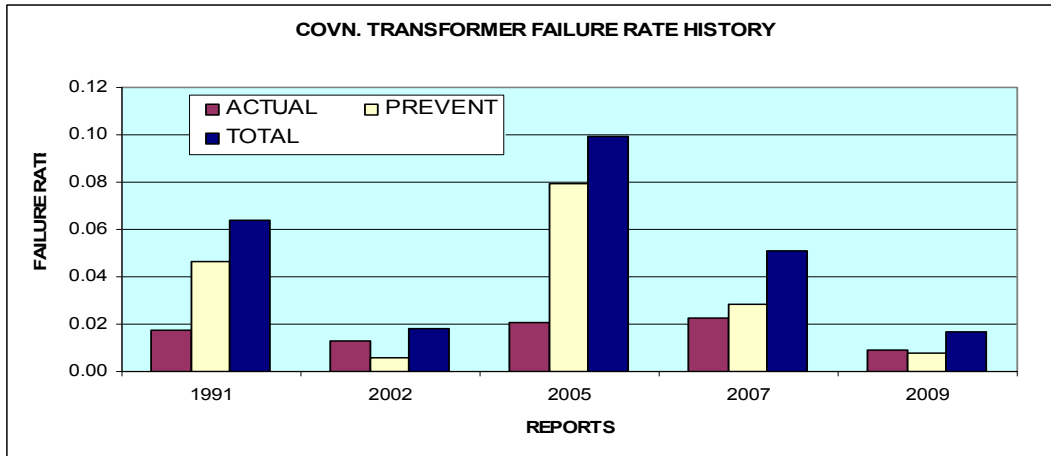
Figure 2. Reported failure rate for the period 1972 to 2009

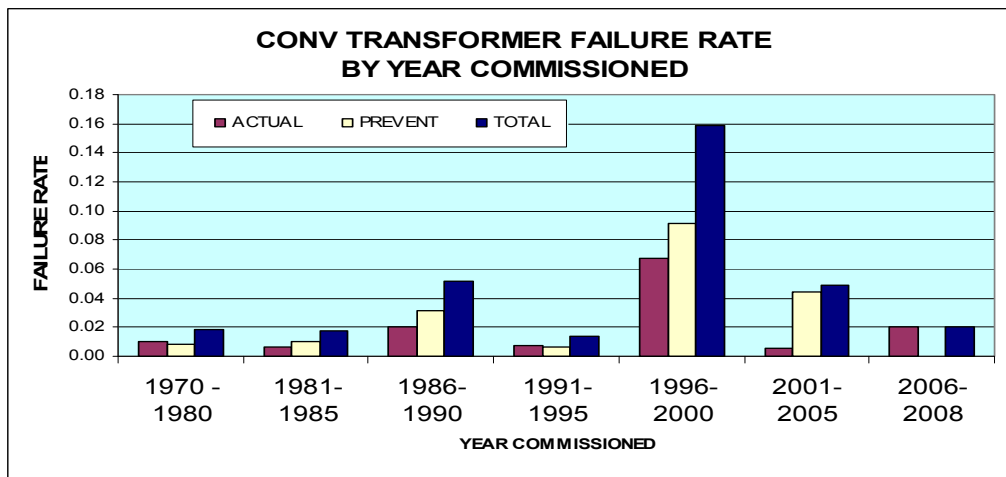
Figure 3. Converter Transformer failure rate by year of commissioning

When the failure rate is plotted against the year of commissioning it can be seen (Figure 3.) that for the systems installed before 1985 the value was low but an increase could be observed for transformers placed in service in the period from 1985 to 1990. It should be noted that this is a period when transformers of ratings of over 300 MVA were installed and a higher DC voltage (500 kV and 600 kV) was first introduced.

The failure rate of the systems commissioned between 1991 and 1995 continued to be low. This is the period when no large rating HVDC systems were installed but only a number of small projects were commissioned.

It can also be seen in the Figure 3. that the failure rate of the systems commissioned between 1996 and 2000 increased again. Most of the systems installed in this period were of higher ratings requiring installation of large Converter Transformers.

The systems installed between 2001 and 2008 presented an increasing number of preventive failures while the number of the actual failures decreased significantly. This phenomenon could be attributed to the following;

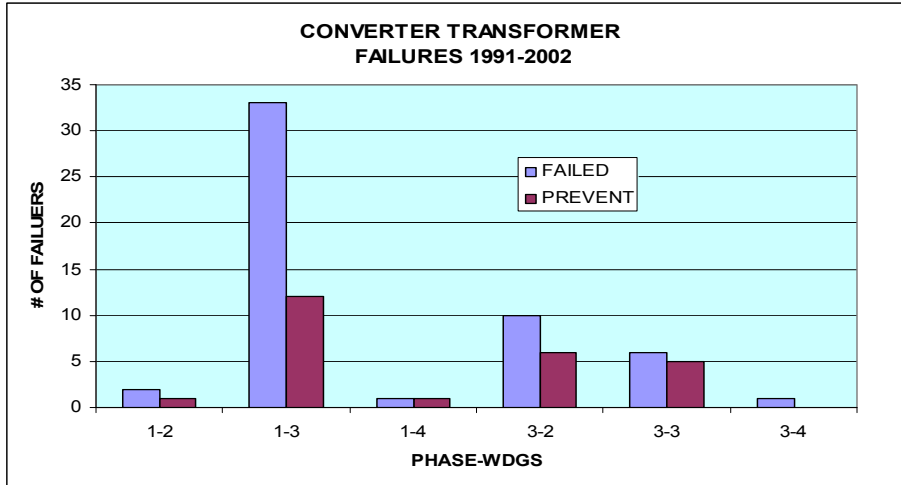
Figure 4. Summary for the period 1991-2002

Figures 4., 5. and 6. show the numbers of failures as a function of the configuration of the winding in the same tank. The winding configurations are defined as follows;

All three figures show that **most failures occurred in single phase units containing line winding and star and delta valve windings**. These transformers were of the ratings 275 MVA and above and installed in the HVDC systems of 500 kV or above. This increased failure rate could be associated with the complex winding, insulation and lead exit design.

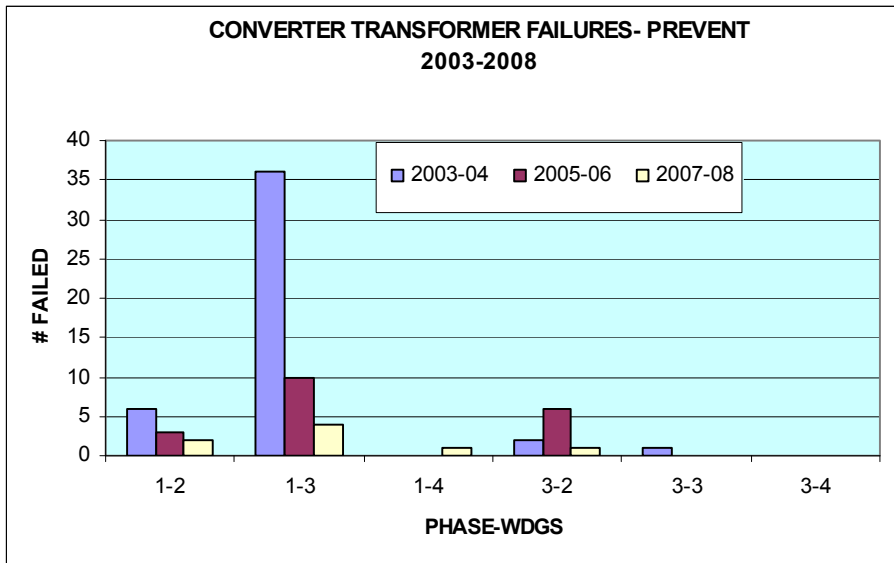
Figure 5. Preventive failures for the period 2003-2008

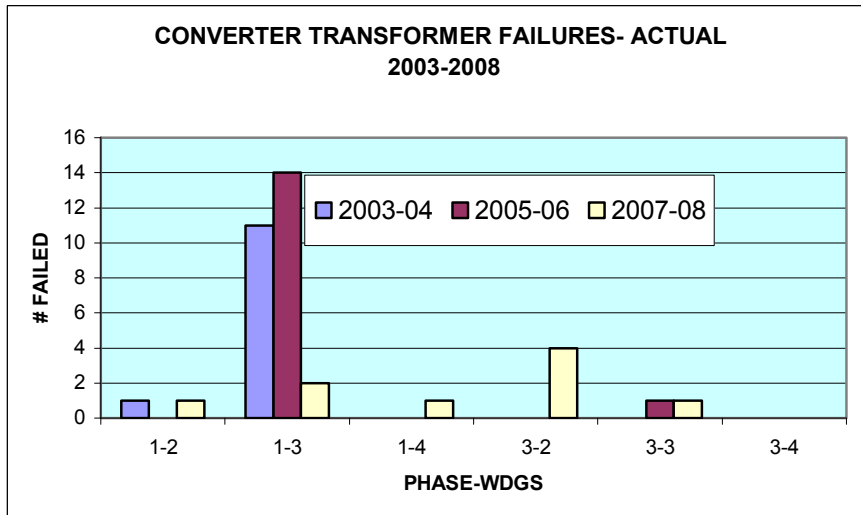
Figure 6. Actual failures for the period 2003-2008

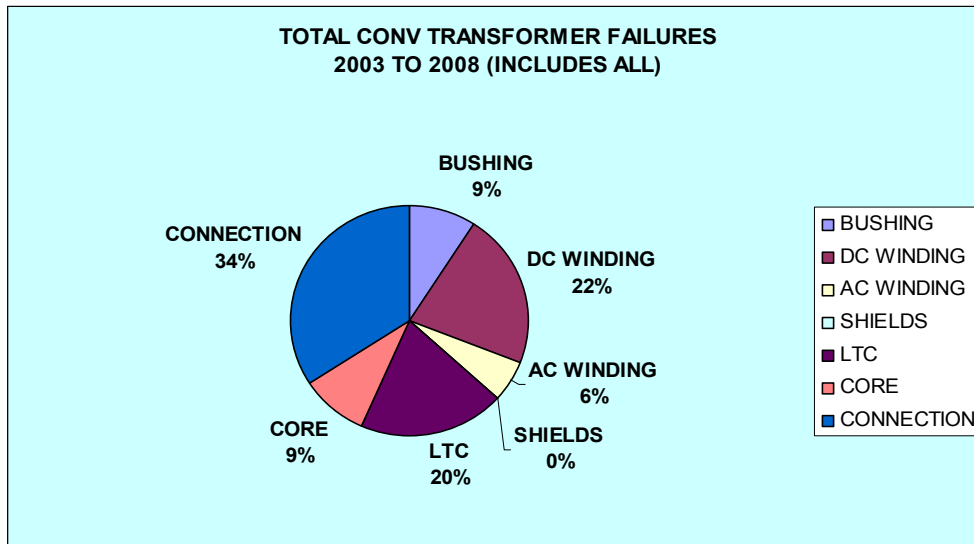
Figure 7. Contributors to Converter Transformer failures including all years of commissioning

Figure 7. shows the total failures (actual and preventive) by components, for the period from 2003 to 2008. This figure includes all the systems that reported **irrespective of the year of installation.**

It can be seen in the figure 7.and figure 8. that failures in the connections, valve winding and OLTCs were the most dominant contributors to the failure statistics when all years of commissioning are taken into account while the failure in the connections remained to be the most dominant factor for the systems installed in the last ten years.

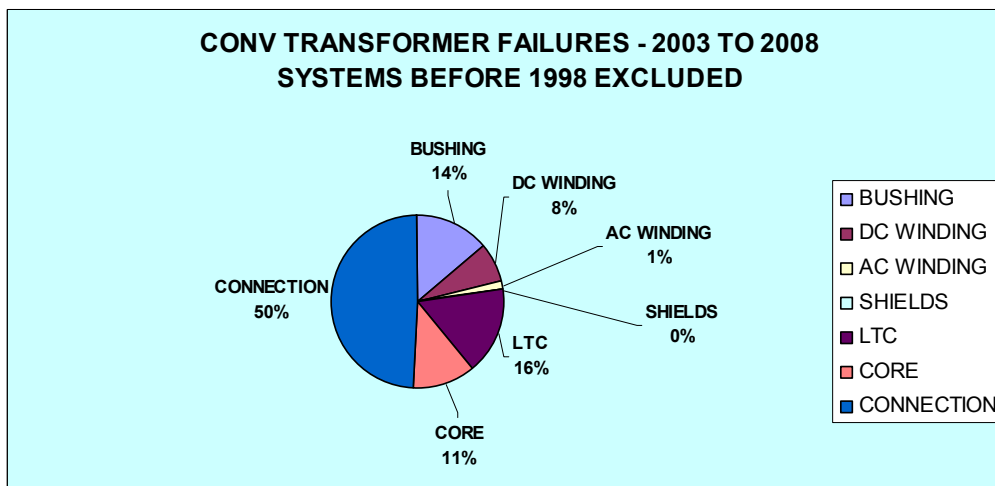
Figure 8. Contributors to Converter Transformer failures excluding years of commissioning before 1998

Figure 8. shows the total failures (actual and preventive) by component for the systems **installed 1998 or later.**

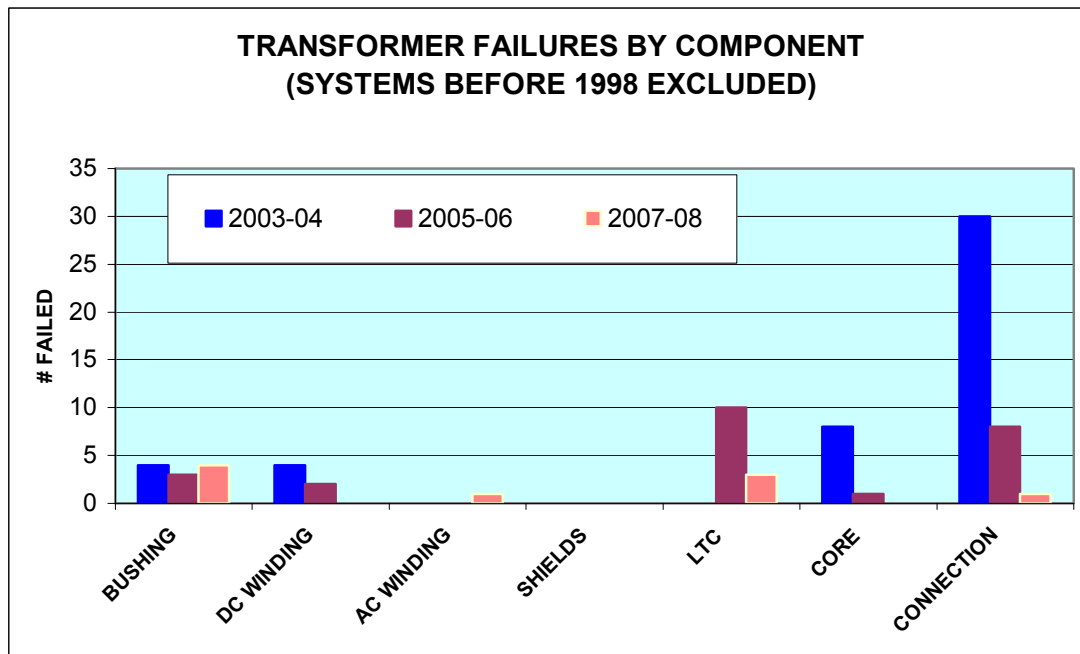
Figure 9. Converter Transformer failures by Component. Systems with the year of commissioning before 1998 are excluded.

Particularly high number of failures in the connections was recorded in the survey conducted in the period 2003-2004 as shown in Figure 9.

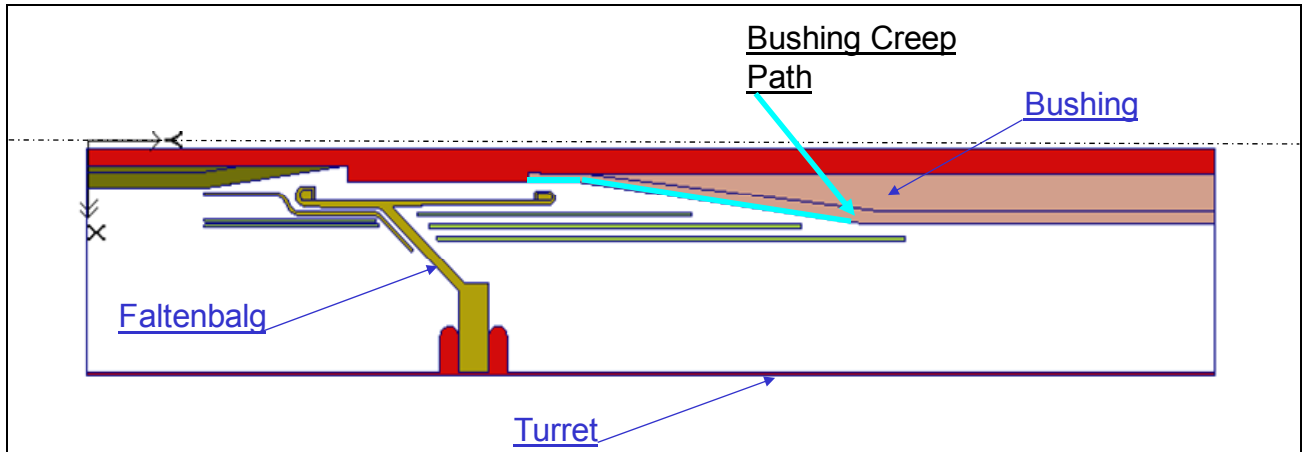
Figure 11. RIP HVDC bushing with its insulation system

To investigate the matter further, a case of an oil side insulation system of an resin impregnated paper (RIP) Valve bushing of an HVDC transformer was chosen. The focus was on the creep (surface) stress on the bushing because this location is known to experience critical stresses during PR.

This insulation system was studied by means of a transient dielectric field FEM simulation (taking into account materials conductivity, permittivity and time). These simulations took into account different:

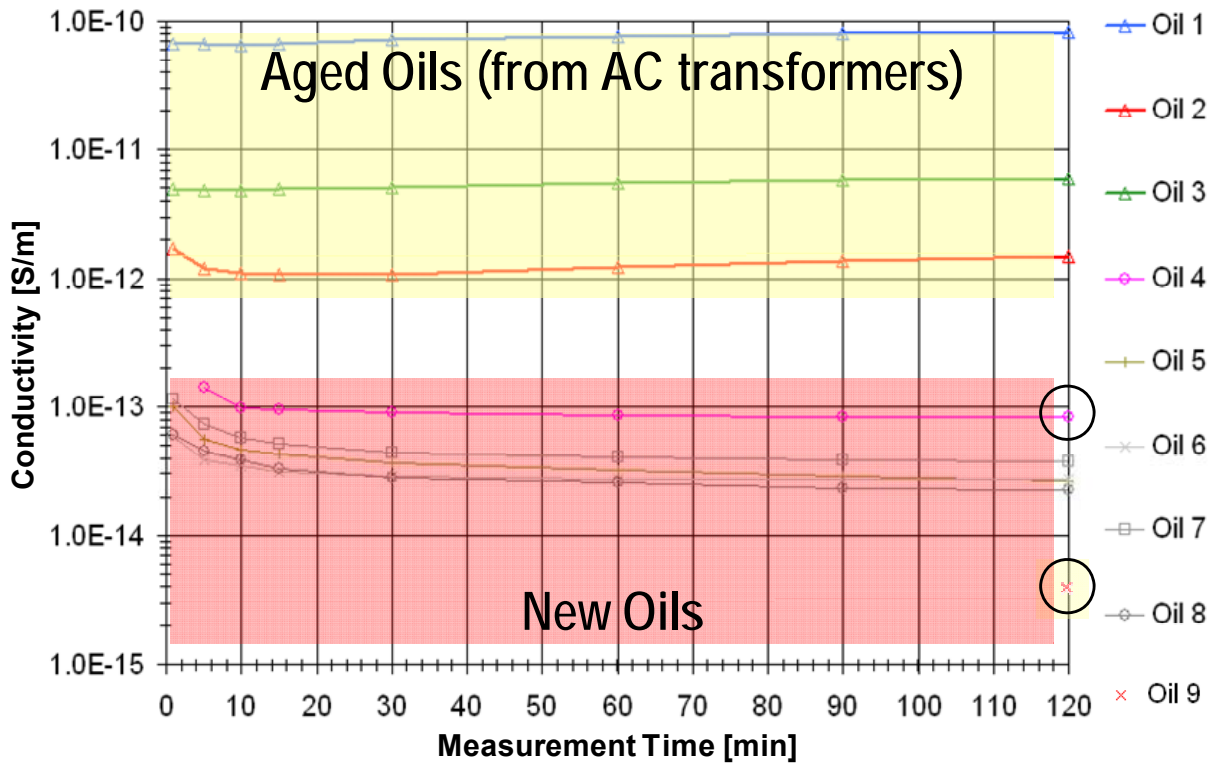
Figure 12. Conductivity of new and aged mineral oils of different type, measured at 20° C, 1 kV/mm

Recent measurements have shown that new mineral oils at 20° C can have electrical conductivities which differ by more than an order of magnitude (while conductivity of oil impregnated high density pressboard remained almost constant). See Figure 12.

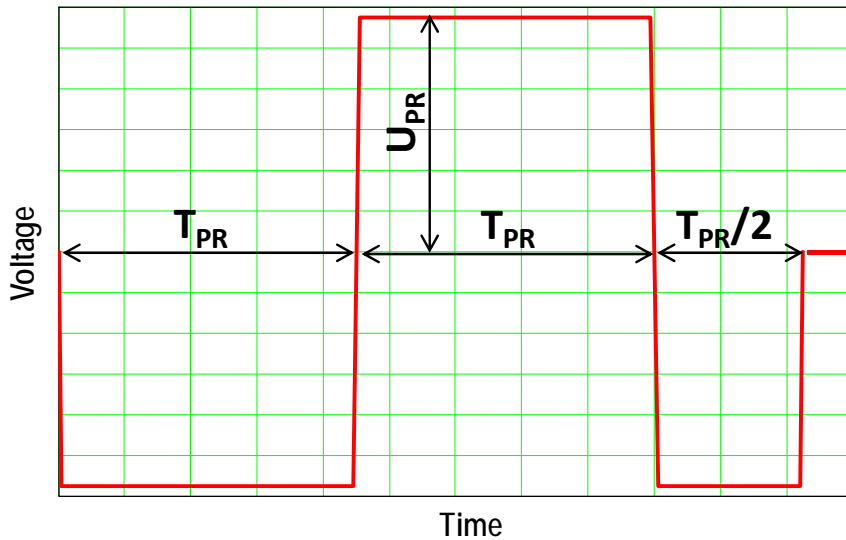
Figure 13. Voltage waveform used for simulations

The first set of simulations looked into the effect of increasing polarization time for the two oil conductivities mentioned above. The voltage waveform is that of the PR-test in Figure 13. with $T_{PR} = 90, 180, 360$ and 720 min.

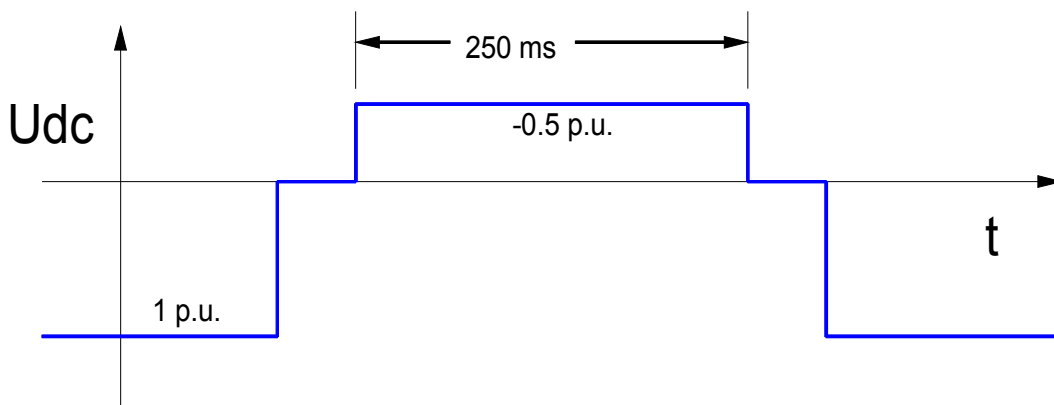
Figure 14. - DC line voltage during a line fault

When a DC transmission line fault occurs the line voltage goes to zero almost instantaneously (in less than 2ms). The rectifier current increases and the rectifier firing angle goes to 90 degrees in order to control the current. The line protection detects the fault within 30 to 50ms and forces the firing angle of the rectifier to 155 degrees. The increase in firing angle causes the DC line voltage to approximately half the nominal voltage in the reverse polarity and extinguishes the fault. After a preselected deionization time (approx. 250 ms) the rectifier firing angle is forced to normal operation (13-18 degrees) and the DC line voltage returns to the normal polarity. The change in polarity reversal occurs in less than 30 ms. Figure 5 shows a typical waveform for a DC line fault.

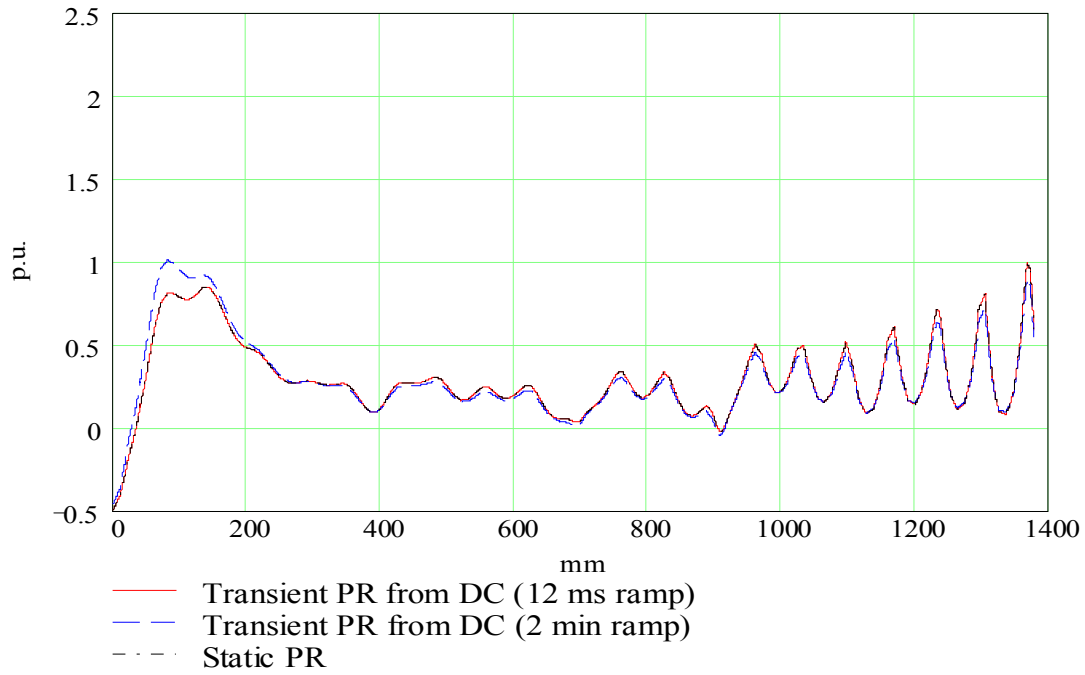
Figure 15. - Creep stress on bushing surface at $t=0$ s after PR completion

Since the polarity reversal in line fault occurs in less than 2 to 30 ms compared to 120 s in the polarity reversal test, simulations were performed to see the effect of the reversal time. Figures 15 , 16 and 17 show the stresses on the bushing surface after various time intervals.

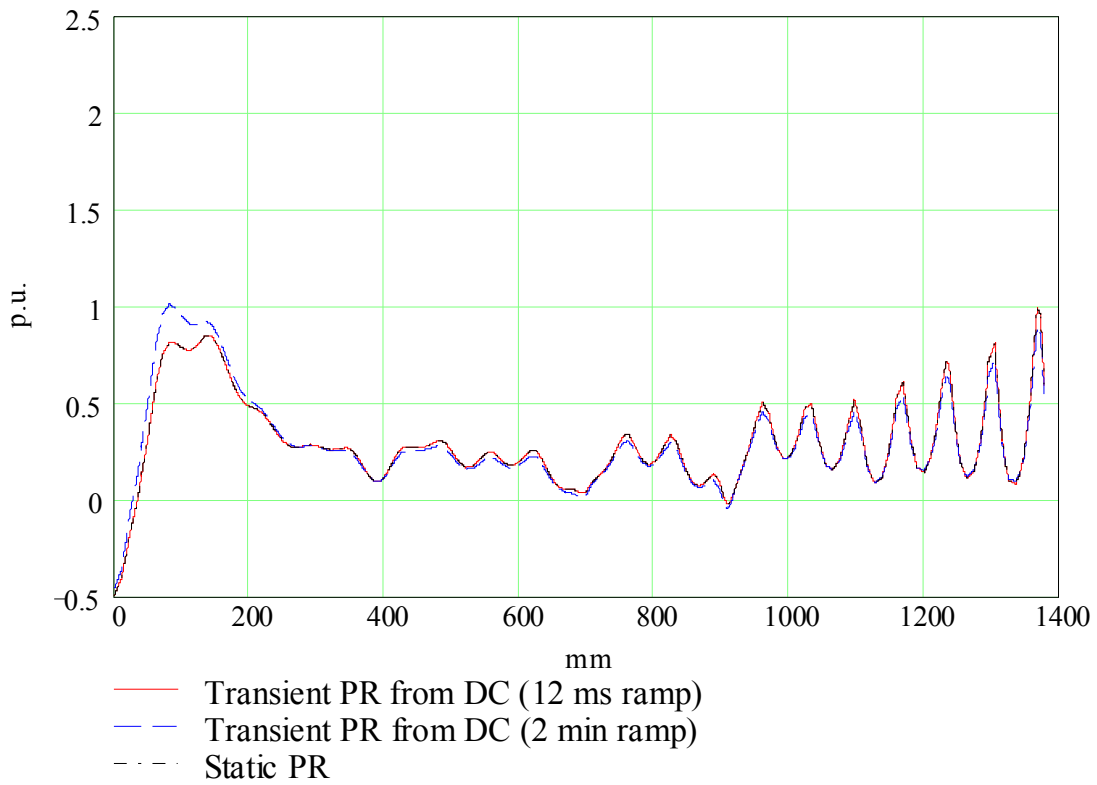
Figure 16. - Creep stress on bushing surface at $t = 300$ s after PR completion

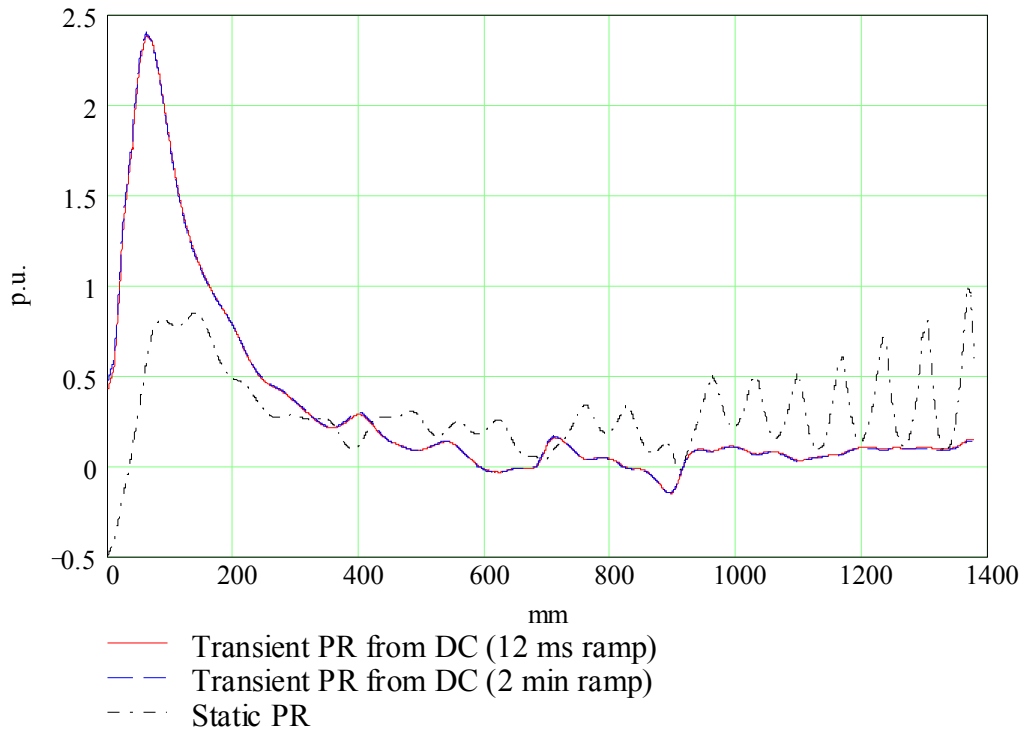
Figure 17. - Creep stress on bushing surface at t - 1200 s after PR completion
