NFPA[®]

909

**Code for the Protection of
Cultural Resource Properties —
Museums, Libraries, and
Places of Worship**

2017

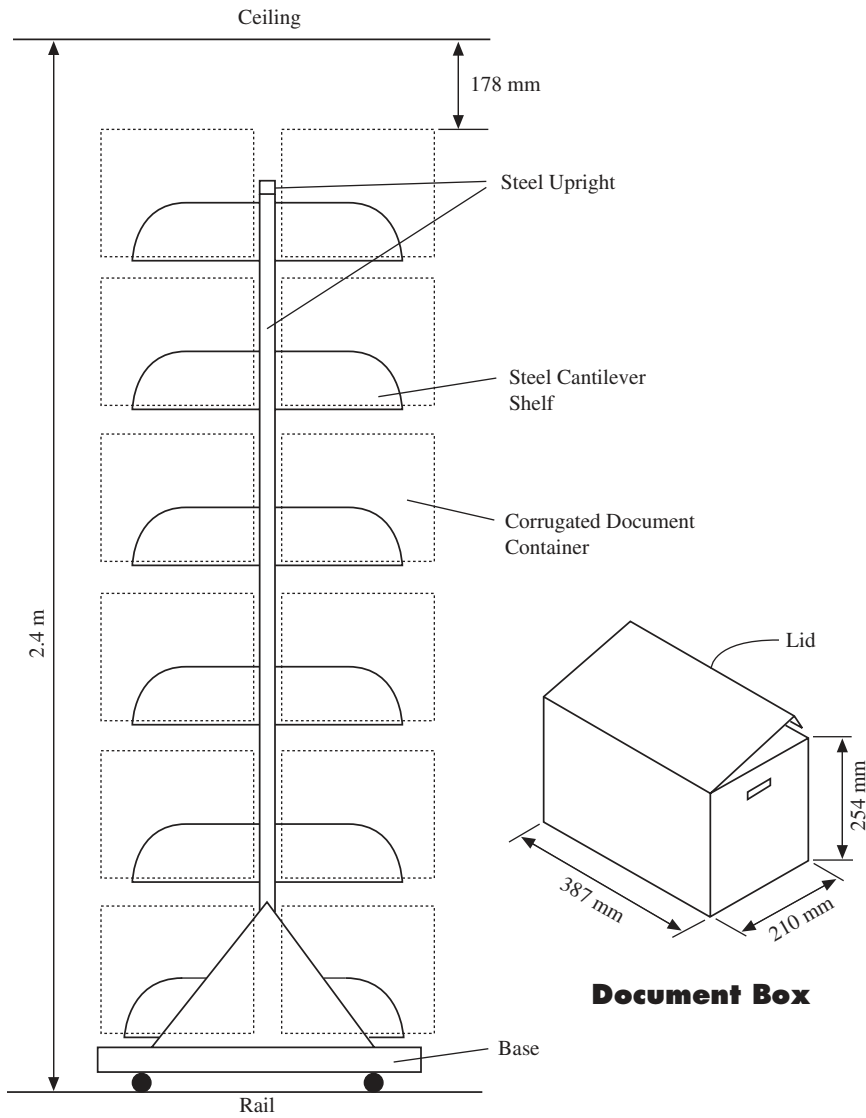
FIGURE G.1(b) End View of Mobile Shelving Unit.

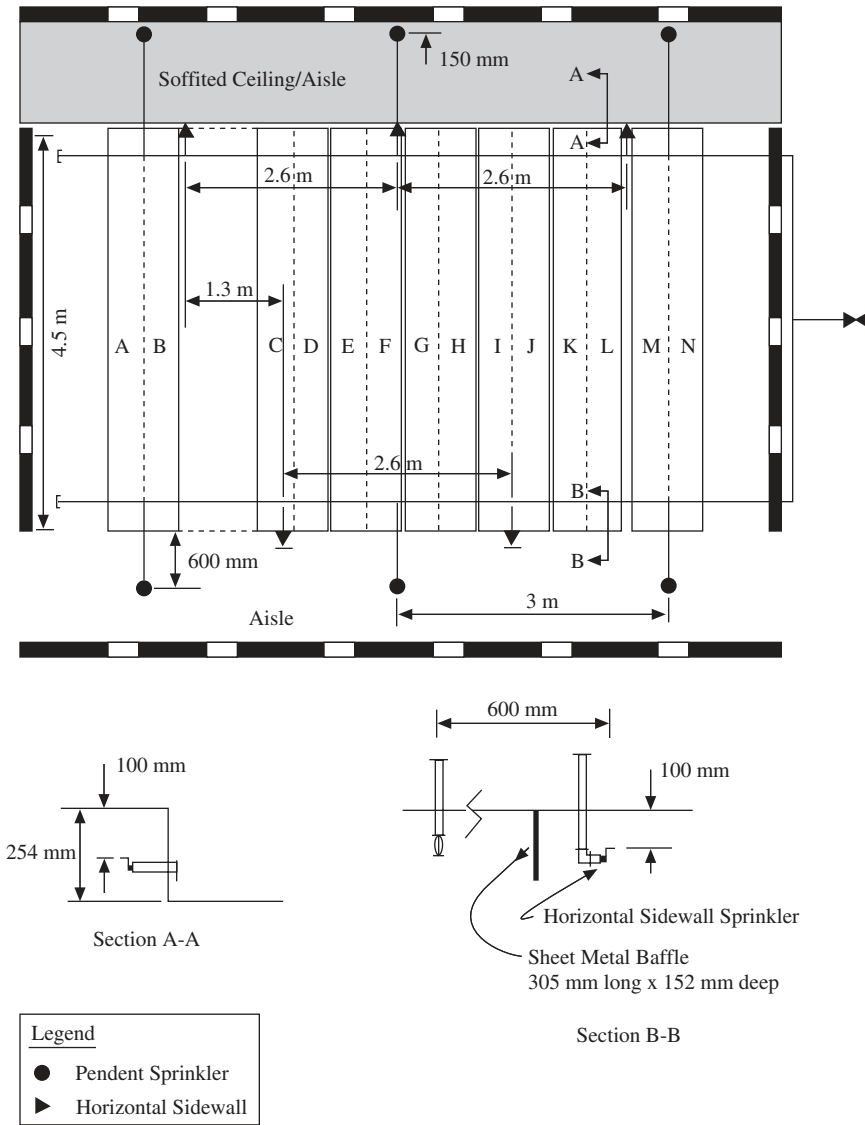
FIGURE G.1(e) Horizontal Sidewall and Pendent Sprinkler Layout.

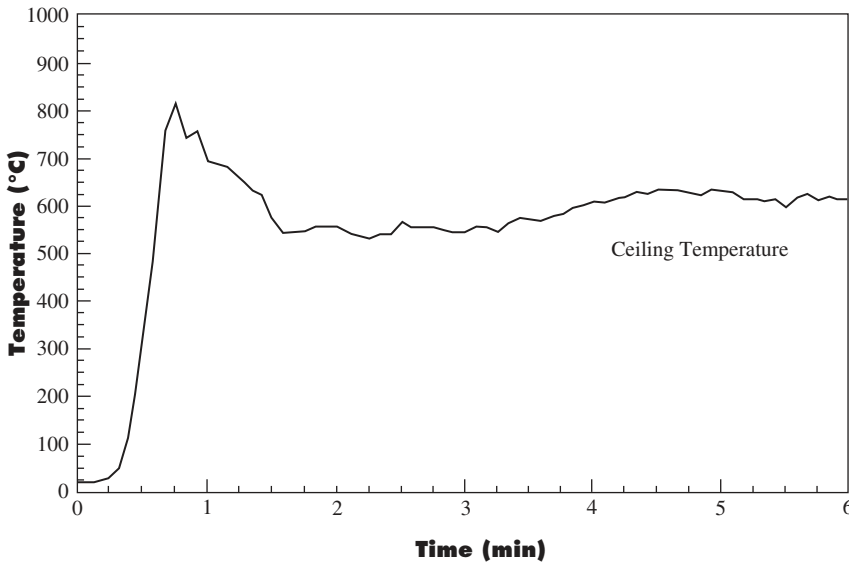
FIGURE G.1(j) Ceiling Temperature in Test 1.

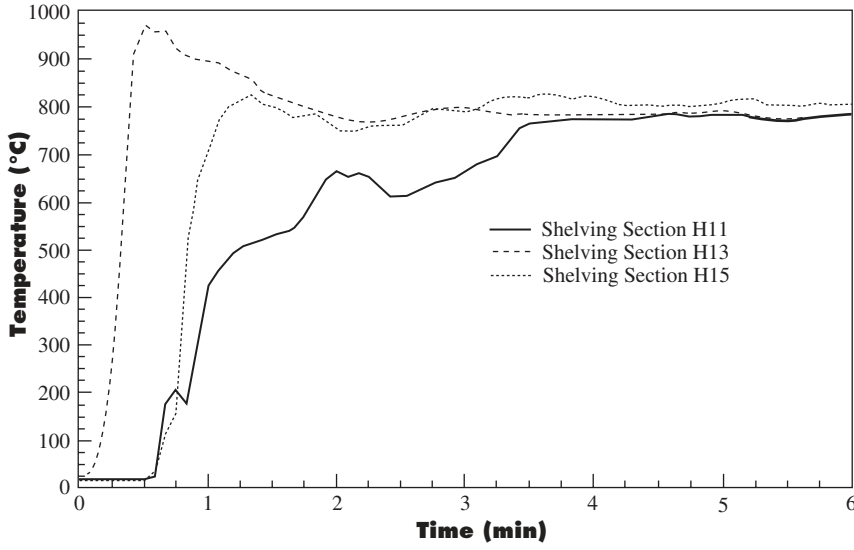
FIGURE G.1(k) Shelving Section H Temperatures in Test 1.

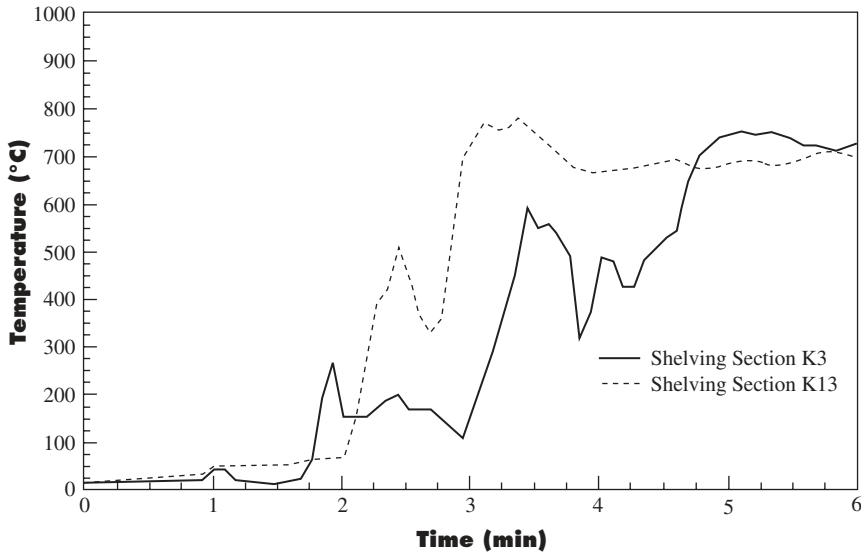
FIGURE G.1(l) Shelving Section K Temperatures in Test 1.

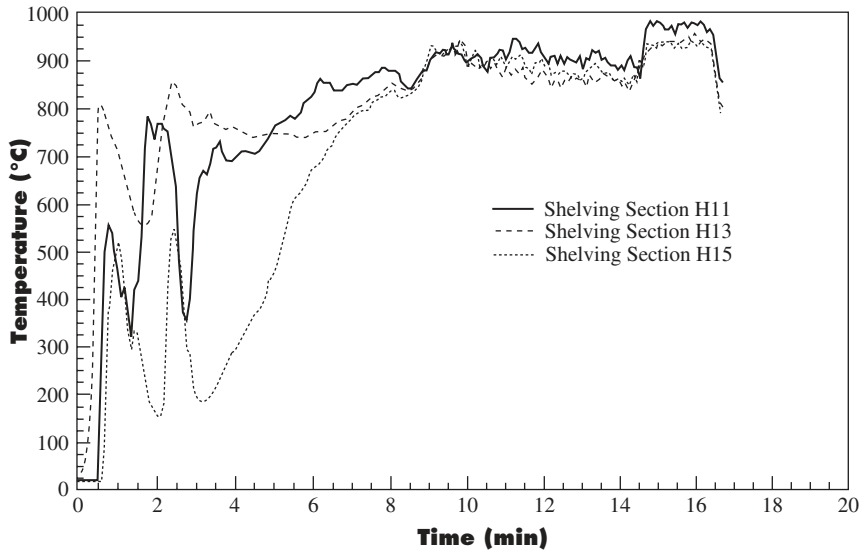
FIGURE G.1(m) Shelving Section H Temperatures in Test 2.

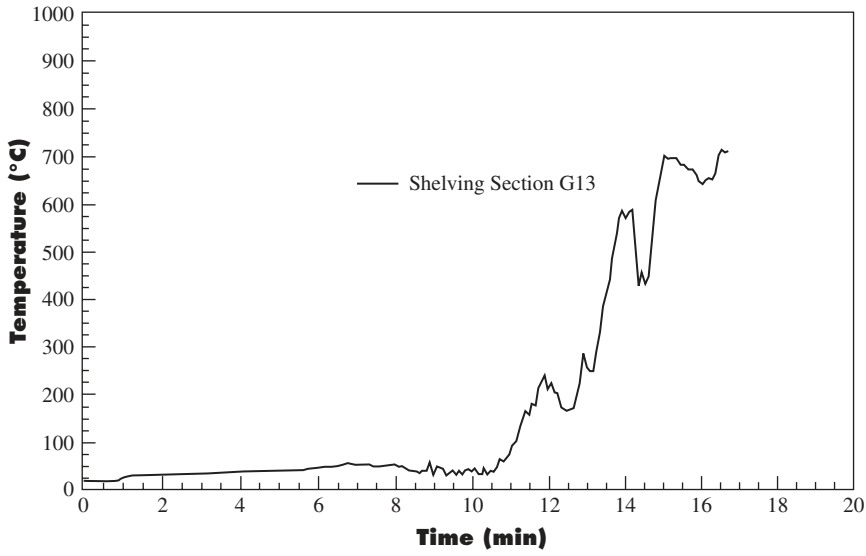
FIGURE G.1(o) Shelving Section G Temperatures in Test 2.

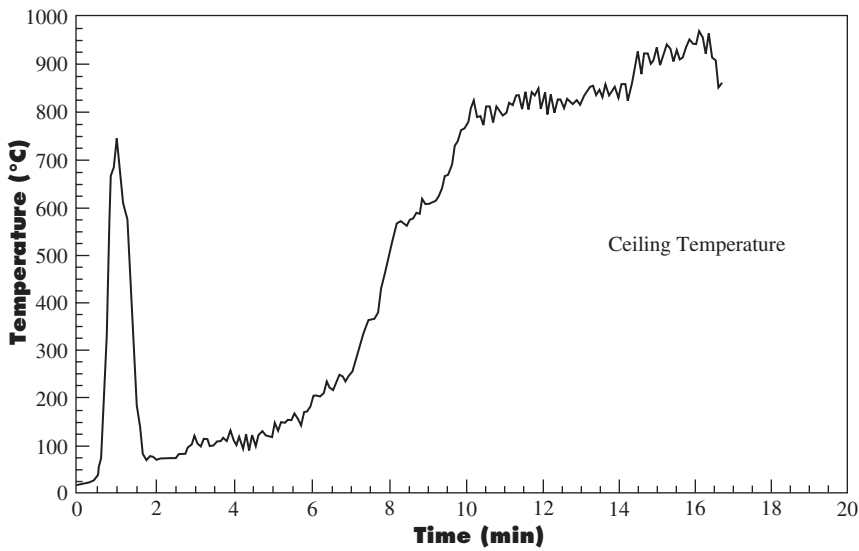
FIGURE G.1(p) Ceiling Temperature in Test 2.

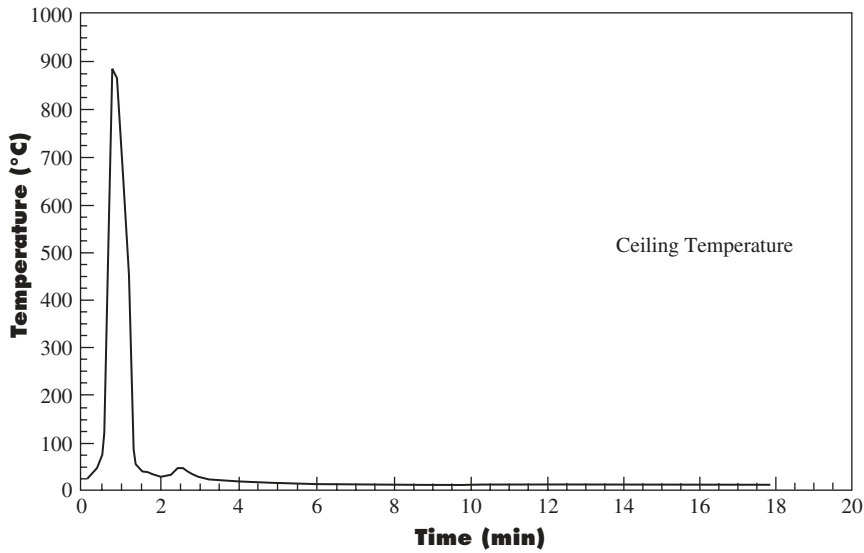
FIGURE G.1(r) Ceiling Temperature in Test 3.

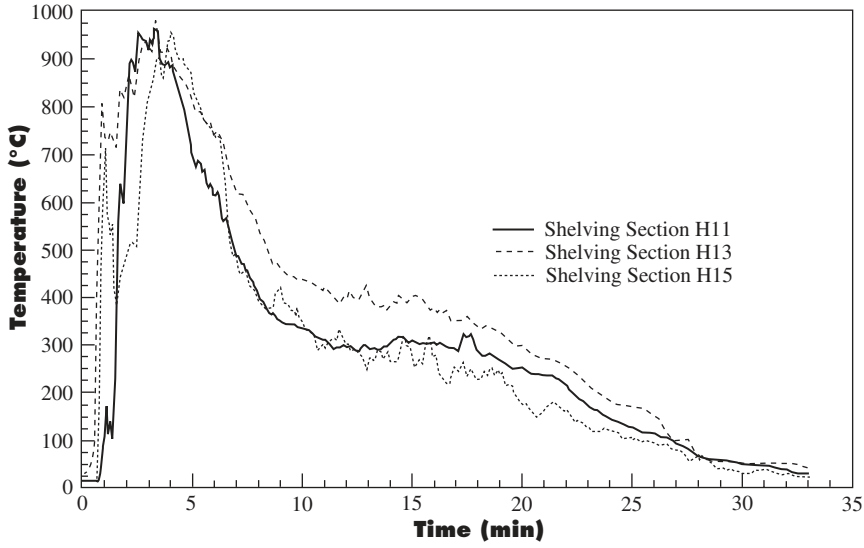
FIGURE G.1(s) Shelving Section H Temperatures in Test 4.

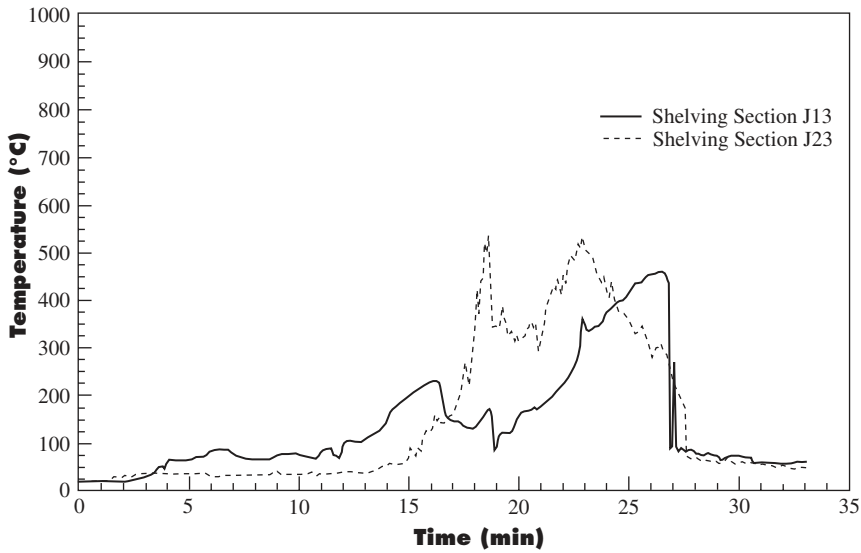
FIGURE G.1(t) Shelving Section J Temperatures in Test 4.

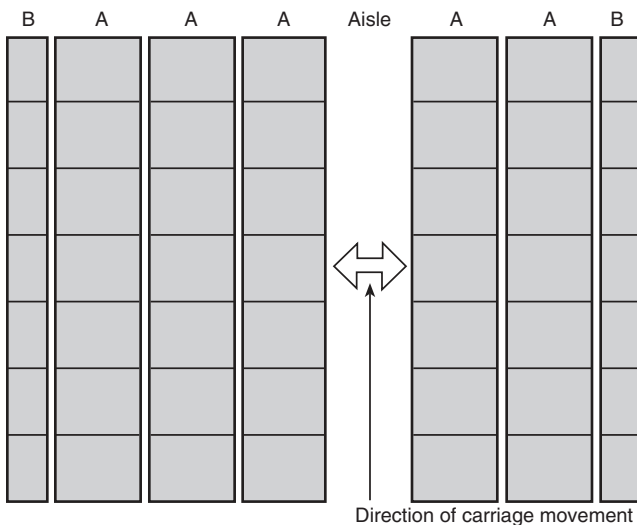
A — Movable carriages for range of shelving
B — Fixed range

FIGURE H.1(a) Moving Aisle Storage.

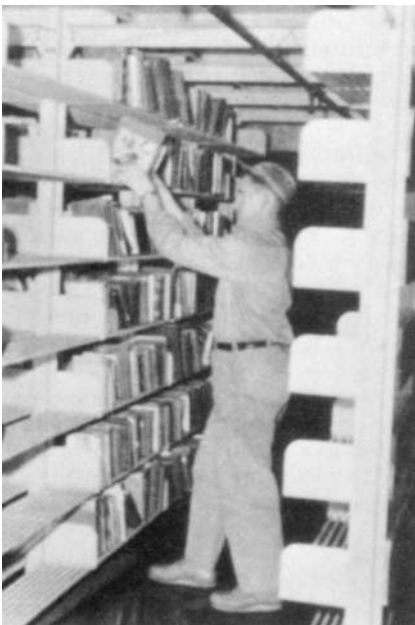
FIGURE L.1(b) Illustration of Structural Elements of Stack; Note One Sprinkler Position.

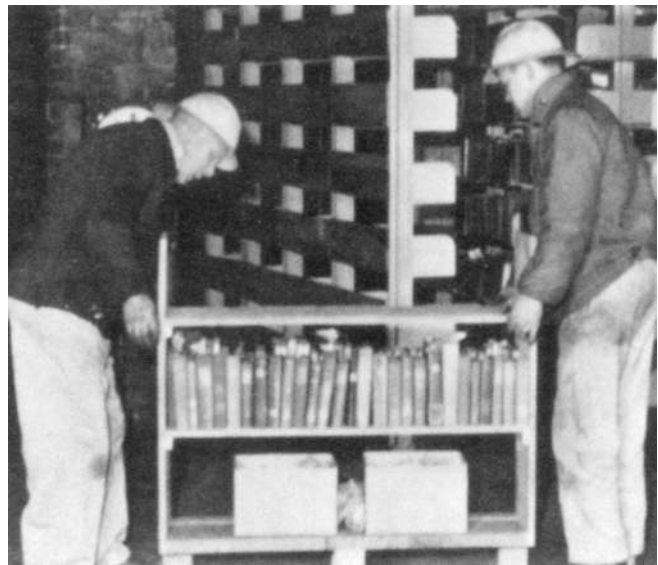
FIGURE L.1(d) Wood Book Cart Before Being Placed in Aisle of First Tier. (After placement, books were put on top shelf of book cart. The fire was started with an ordinary match by igniting the crumpled piece of paper between the two cartons on the bottom shelf of the cart.)

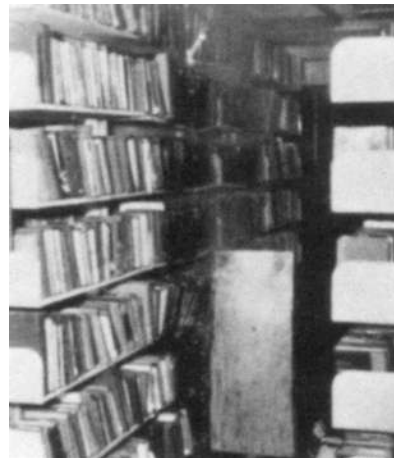
FIGURE L.1(h) After Fire Extinguishment by Sprinklers; Fire Damage to Books in Only 10 Percent of Space.

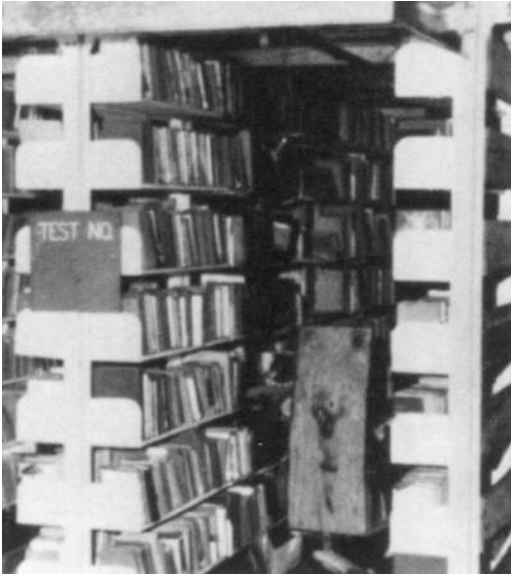
FIGURE L.1(i) Close-up of Extent of Fire Damage After Test 1 with Automatic Sprinklers. (Note limited area of fire damage.)
